# Strategies for the Restoration of Slopes in Cusiana River's Watershed (Colombia)

## Abstract

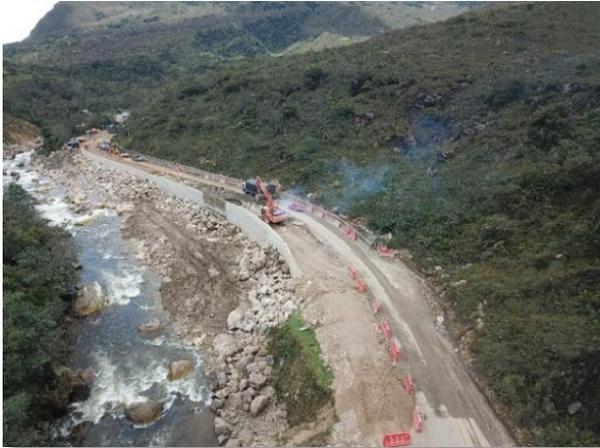
**1. K50+300 y K50+540 Rockfill and retaining wall with piling**

According to the Vías equidad 046 consortium, in the section K50+000 – K50+620, in which the roadway goes through Cusiana river flow, its torrential tendency has affected historically the river banks' stability causing sideways scour problems that affect either the river containment wall stability, or the stability of the deposits on the left sideway, which bring rockfalls that hit the existing walls and rockfills, producing the loss of confinement in the roadway bank. The roadway bank is on the alluvial deposits (Qal), causing serious problems of sideways scour and impacts on the transported block on the existing containing wall and rockfills. All of this while on a high longitudinal slope from the river's flow in the area. The scour problems also influence the river's right sideway.

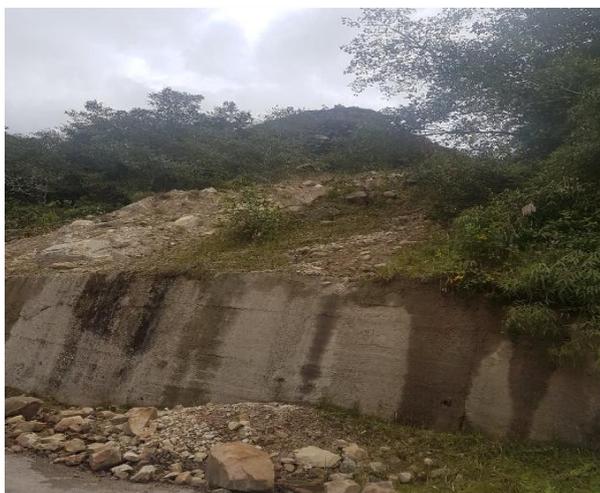
**2. K50+800 Rockfall**

There is a flow of big-sized debris in a non-consolidated deposit because of the concentration of water and the saturation of soil. Besides, there is a sideways scour in the right river bank. The license advises the installation of piling tangent to the road to protect the bank, and protecting rockfill in the right river bank in order to decrease the damages caused by the bank erosion in this section.

In K50+800, it can be used the technique of flexible systems of high strength anchored to the ground given that, in Fernandez's [7] thesis, he explains how this methodology can prevent rock or soil slides. It consists of a flexible membrane formed by a network of cables or a wire mesh, which is attached to the ground through anchoring, generally anchor bars (bolts) and allows to incorporate horizontal or vertical reinforcement cables that come together in the bolts creating square patterns. This strategy allows us to avoid that soil slides or rock falling reach the drive way, which is what has been found in the study area; this is why we consider it is appropriate since, as shown in Figure 2, the slope is close to the driveway and an incident like this would cause the complete closure given the debris flow that would fall on the road. In the winter seasons (May to August), there is an increase in the river flow when there are heavy rainfalls, causing a progressive erosion rise in the sideways of the road, the consortium in charge proposed a rockfill over the inner slope. Chávez, Blanco and Watson state that the changes in the river course and the construction of development works over one of its banks have resulted in an instable slope, prone to slides and mudslides that cause

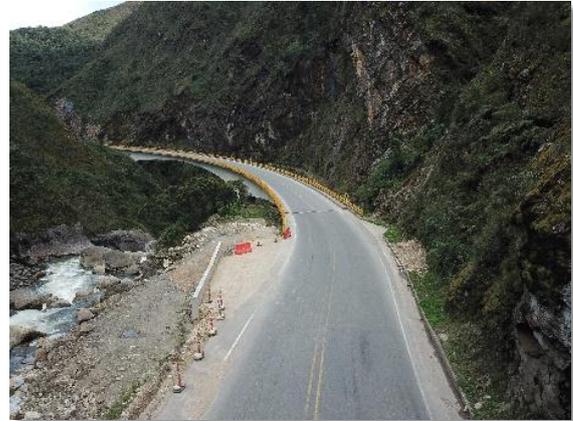
**3. K52+850 Peña de Gallo bridge**

This point is one of the most critical ones in the area since there are frequent landslides caused by the heavy rainfalls and these blocked the freight car's pass. To solve this issue, INVIAS decided to change the alignment of the roadway with the construction of a viaduct in order to solve the reduced mobility and protect the freight cars. In the viaduct's construction, they drained the water flow to avoid it impounds. This construction costed 7,3 million USD, and it is a kind of a cantilever bridge subsequent and weighted. It has a 360-meters-long constant curve y a 11-meters-long section. This structure facilitates the communication between the municipalities of Aquitania, Sogamoso, Pajarito, Aguazul, Yopal and Arauca.

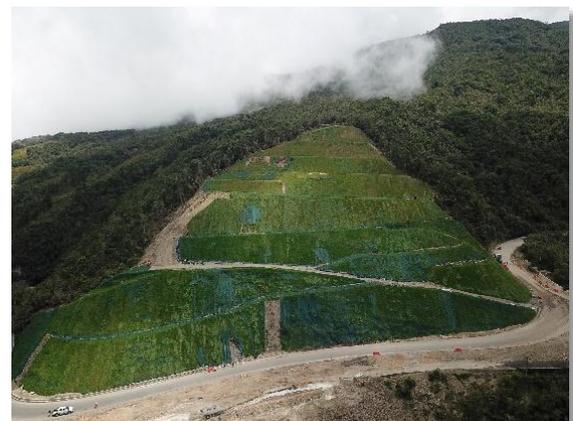
**4. K56+000 Geomanto y biolodo**

There was a great magnitude landslide in the slope because of the saturation of the soil due to the heavy rainfalls. It was decided to stabilize by the terraces mining method, 7 meters width each, every 10 height meters, and protect the slope with geomat, which is a high-strength mesh-made synthetic fabric that allows the growth of grass seeded with bioslurry. Wherever grading is done, grass must be seeded according to the area.

As shown in Figure 7, the final appearance of the structure is natural, it contains a geomant that helps its waterproofing and it also allows the flora's growth in the external surface, it is draining in the frontal parameter. Cesar Augusto Urteaga Posadas researched another stabilization strategy using the Erdox system, shown in Figure 11. This system consists of a retaining wall that has a mono-anchor, which is made with a pyramid-shaped metal structure. The author states that some of the advantages of this structure are quick installation, lightweight, immediate stability and also, it can be previously assembled in a nearby place [9].

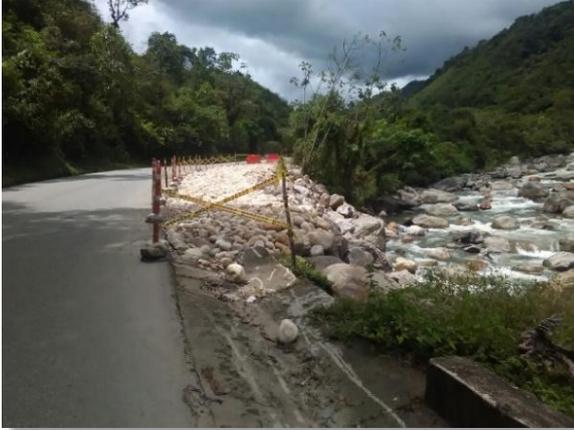
#### 5. K76+300 Rockfill

While roadway maintaining work was being made, Cusiana River had an increase of flow that affected part of the inner slope. It was immediately decided to implement an approximately 100-meter-linear-long rockfill to protect the slope; besides, there was an improvement in the roadway and reinforced concrete ditches.

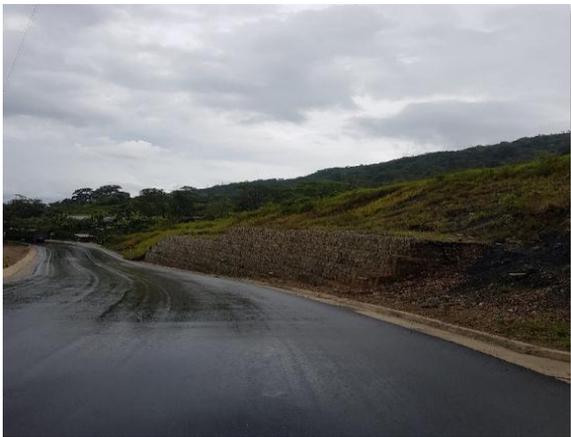
#### 6. Gabion wall and draining constructions K80+000

There was a great magnitude landslide in the slope because of the saturation of the soil and runoff water, it was decided to implement a gabion wall to protect the roadway because the sideways hill was low. Some filter trenches were constructed to drain water to the closest gorge.

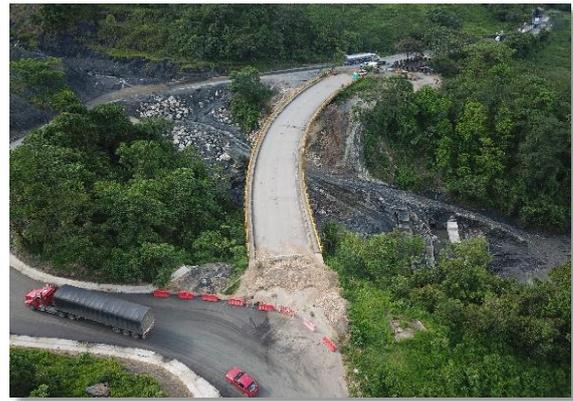
#### 7. La Orquídea Bridge K86+510

There was a mass removal process in the sideways, and it brought a movement in the northern stay of the bridge to the lower part of the sideways causing a 20 cm uplift and a breaking approximately in the center of the light. This incident compromised the closing pour and the next to this one. Afterwards, the bridge was closed for security purposes and a pan was constructed over the gorge. The construction of a 60-meter-long FEEILY bridge is proposed which is supported on three in piling in each stay with a diameter of 1,50 meters and a depth of 35 meters. The bridge would cost 2 million USD approximately.
