Emergency Dewatering and Drainage Technology and Its Application in Urban Underground Space

Wang Bin

The Third Exploration Team of Shandong Coalfield Geology Bureau, Taian, China

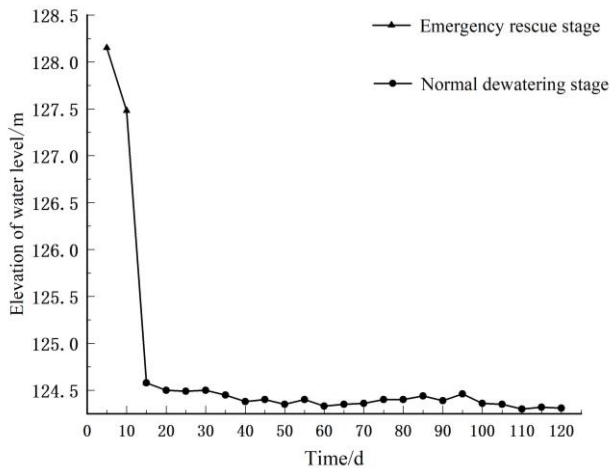
Figure 1 Comparison diagram of underground dewatering depth

site for dewatering. The average water level dropped from 128.15 m to 127.70 m with a dewatering depth of 0.45 m, indicating an unobvious dewatering effect. In the later stage, the tube wells were densified, the well depth was increased, the water level in tube wells decreased from 127.70 m to 124.30 m with a dewatering depth of 3.4 m, and the total dewatering depth reached 3.85 m in the emergency rescue stage. The reason was that with the increase of the number of tube wells, the decrease of well spacing, and the increase of well depth, the groundwater displacement in the garage and surrounding areas increased, and the average groundwater depth increased. See Figure 1 for the average underground dewatering depth before and after adjusting the number of tube wells.

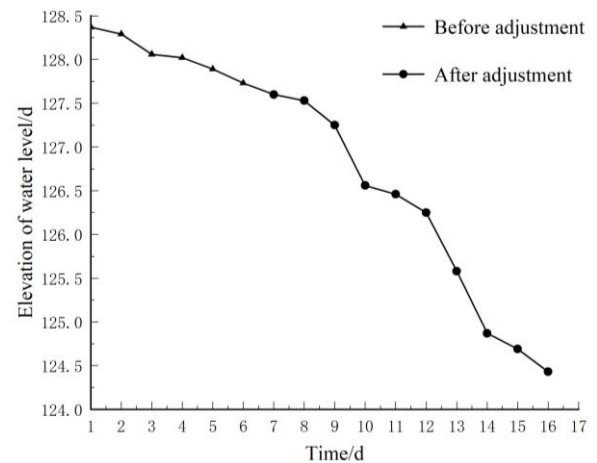
Figure 2 Tendency chart of groundwater level change

Group wells operated during the dewatering period in the garage. As the groundwater level declined, the group well effect was gradually evident. In the later stage, the single-well water pumping capacity presented a declining trend due to the reduction of groundwater volume, submersible pumps no longer operated in full load, and the single-well water discharge was a variable value. To ensure that groundwater was kept a stable safe level, therefore, the pumping capacity was controlled by controlling the electrified pulse delay of water pumps. The water pumps were started every 4 h (for 0.5 h each time), effectively preventing the burnt-out phenomenon of water pumps due to divorcement from the water surface and their idle running for a too long time, improving the dewatering efficiency, and saving the cost. During the normal dewatering period, the groundwater level was kept under a dynamic balance, the groundwater level was observed for 2-3 times per week and changed within 124.3 m-124.5 m, and the dewatering depth changed less in comparison with that in the emergency rescue stage, not exceeding the safe water level of 124.5 m. The change in the groundwater level is exhibited in Figure 2.
