Case Study for Repair Methodology of Old Industrial Structure Made of Brick Masonry

III. DESCRIPTION OF TURNING SHED

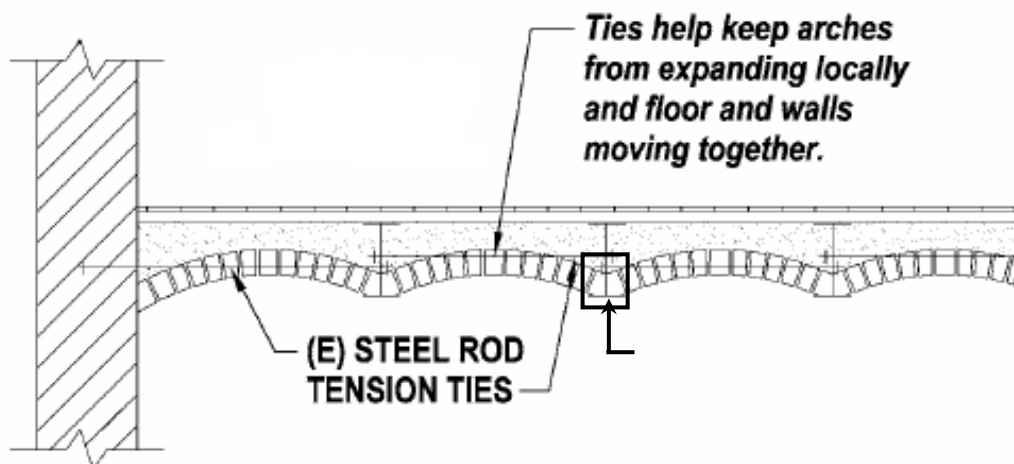
SKETCH I: SKETCH SHOWING CROSS SECTIONAL VIEW OF JACK ARCH

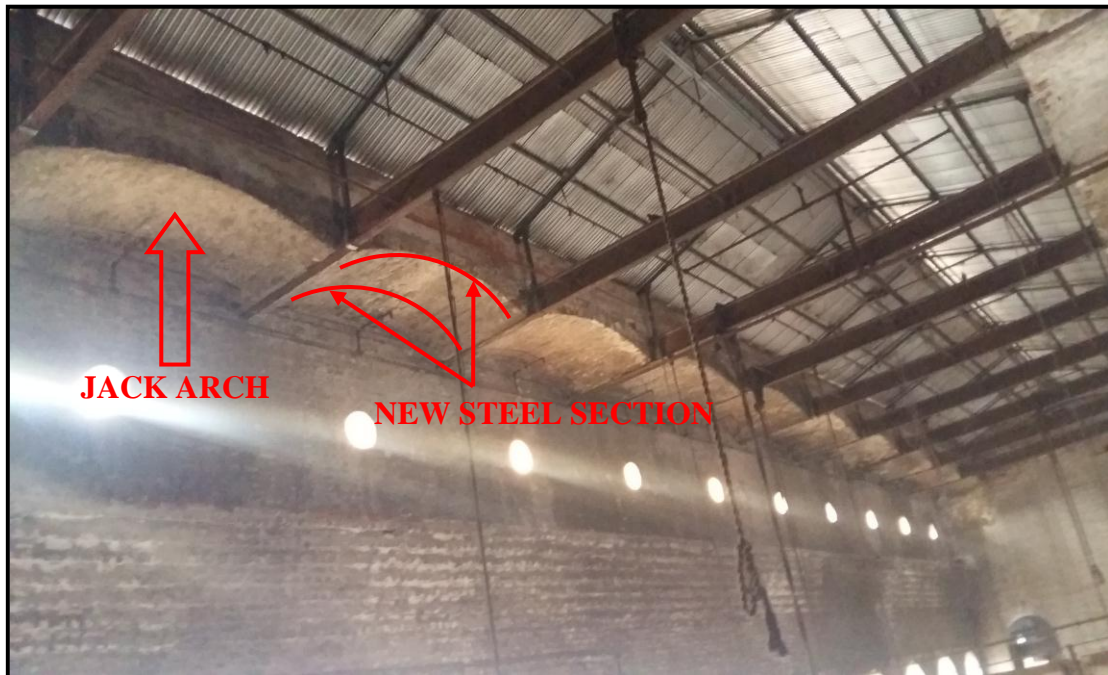
PLATE 1 : VIEW OF JACK ARCH MADE WITH BRICK MASONRY AT TURNING SHED.
STEEL SECTION IS TO BE WELDED AS PER SKETCH.

- Steel angle (ISA 50 506) is to be bent to match profile of soffit level of Jack arch as per Sketch-II.
- Steel angle is supported and welded with bottom level steel joist so that steel angle should touch bottom portion of jack arch. This strengthening technique will not allow Jack arch to further deform in downward direction.

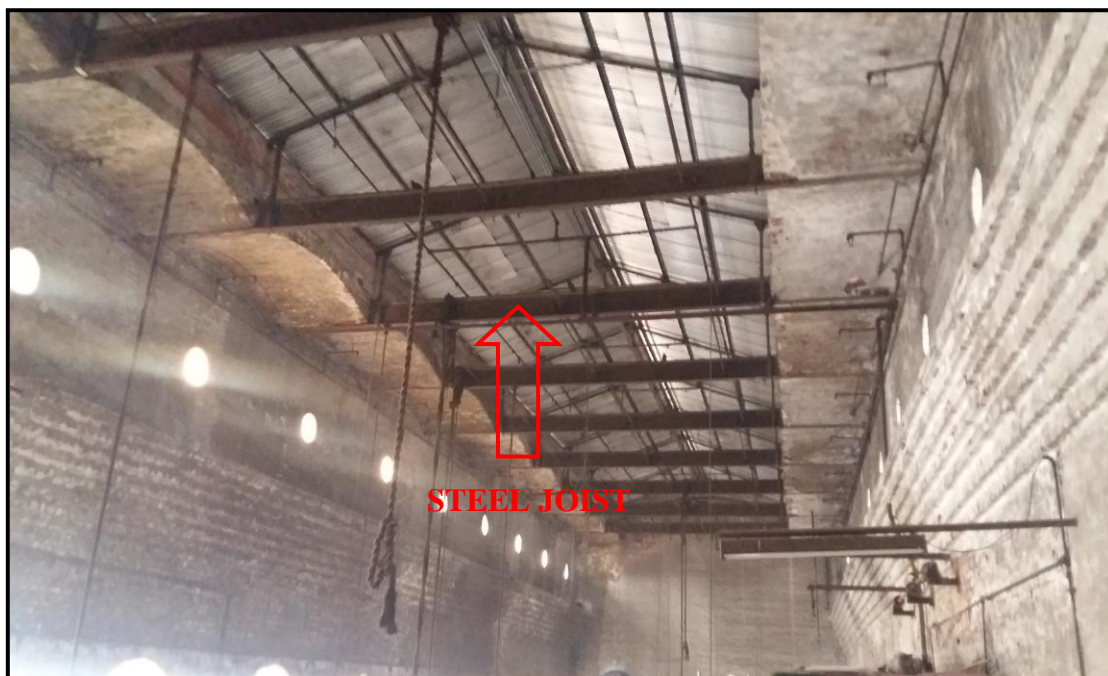
- It may also be concluded by the nature of crack near support area, these cracks are generated due to corrosion of steel joist.
- Corrosion of steel joist near Jack arch support is noticed. Supporting area of steel joist is encapsulated by brick structure of jack arch, so it is wise not to disturb that support area. Disturbance of support area of steel joist is not advisable as that may disturb overall stability of jack arch.
- Repair work is to be done externally without disturbing stability of Jack arch.
- Jack arch portion of roof is distressed in many places. Due to long service life, geometric deformation of roof arch is noticed. Loss of mortar from bottom surface of the arch is also noticed.

PLATE 2 : VIEW OF CORRODED STEEL JOIST.

- Exposed steel joist has shown moderate level of corrosion. Those exposed steel members are to be painted with anti-corrosive coating system after removal of corrosion.

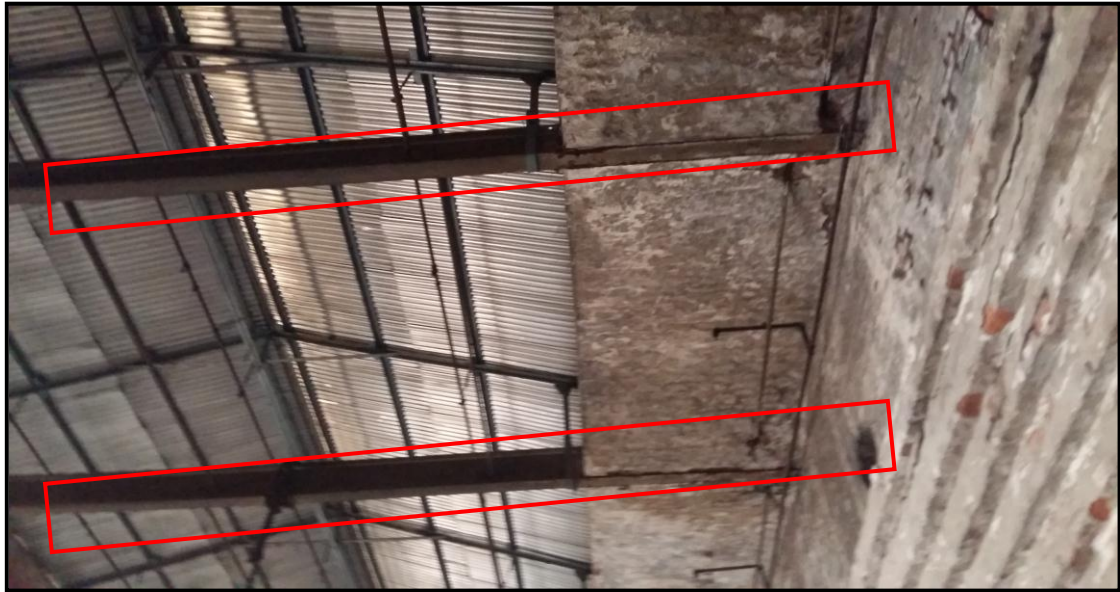
PLATE 3 : MODERATE CORROSION AT STEEL JOIST.

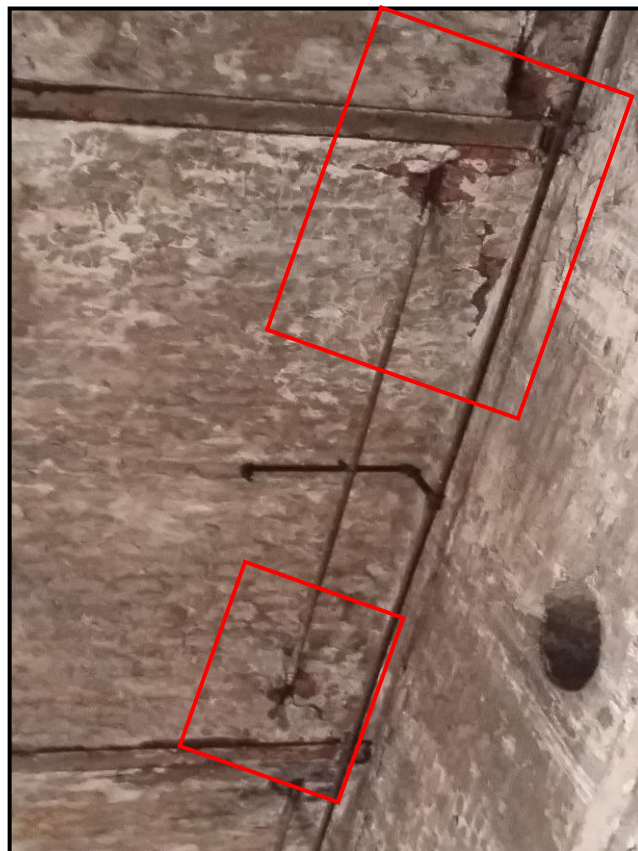
PLATE 4 : DE-LAMINATION OF CHUNK.

- As some chunks of lime mortar / plaster is falling into the workspace area. To arrest this unsafe phenomenon following repair methodology may be adopted

- Strengthening scheme of Jack Arch portion
- To counter permanent geometric deformation of arch following strengthening technique is adopted.
- At first loose mortar is eliminated by gentle manual chipping. Sound dust free substrate is exposed manually.

- Re pointing of mortar line is done with Polymer Modified Mortar.
- After pointing of mortar area plastering of soffit level of Jack arch to achieve smooth surface and to ensure a proper geometry of arch.

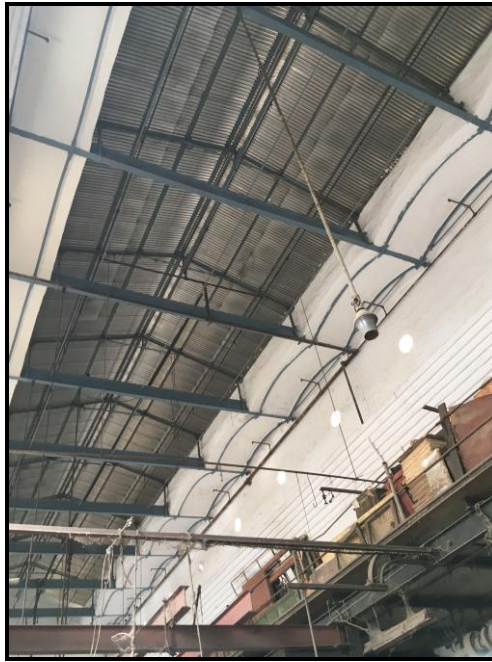
PLATE 5 : PHOTOGRAPH SHOWING CONDITION OF ROOF STRUCTURE AFTER REPAIR.

After execution of repair works, site has been inspected thoroughly to investigate performance of the structure after repair. All corroded surface of steel joist have been painted with anti corrosive paint and Jack arch portion is strengthened with steel frame form bottom. No further cracks and seepage marks are noticed at the soffit level of Jack arch. Overall performance of the structure after repair found to be satisfactory.

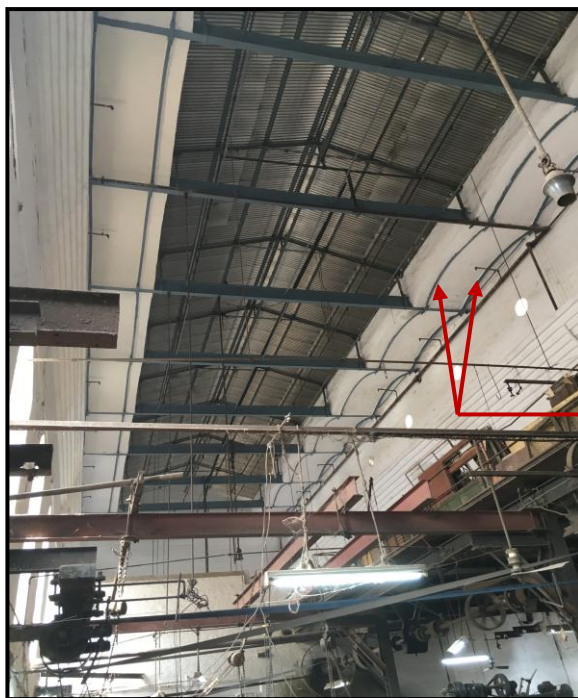
PLATE 6 : PHOTOGRAPH SHOWING STRENGTHENING OF JACK ARCH AT SOFFIT LEVEL
BY ISA 50x50x6

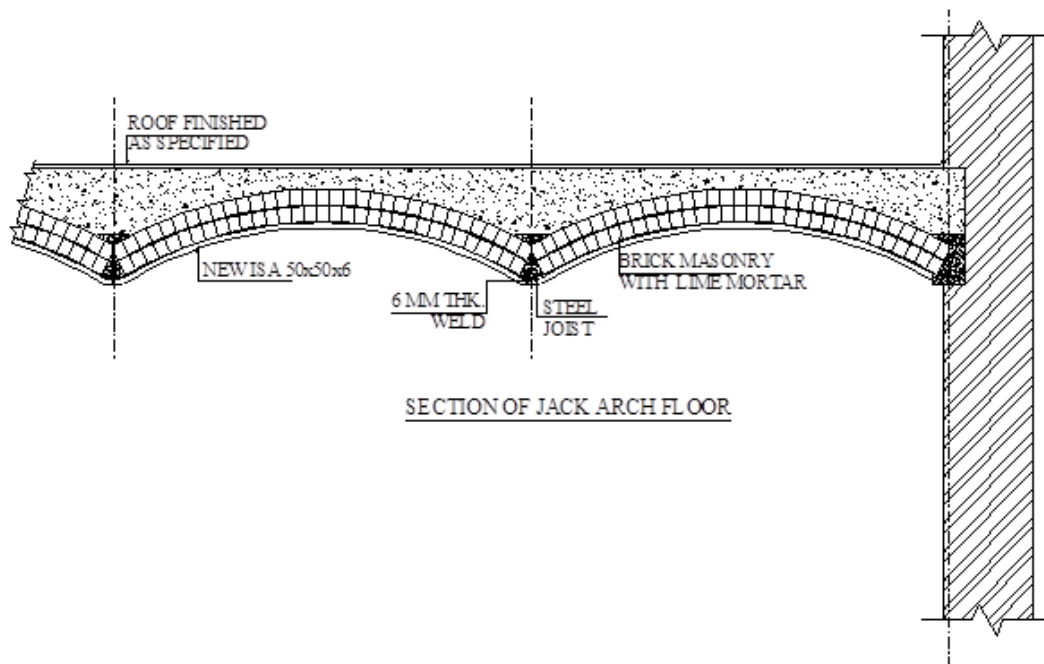
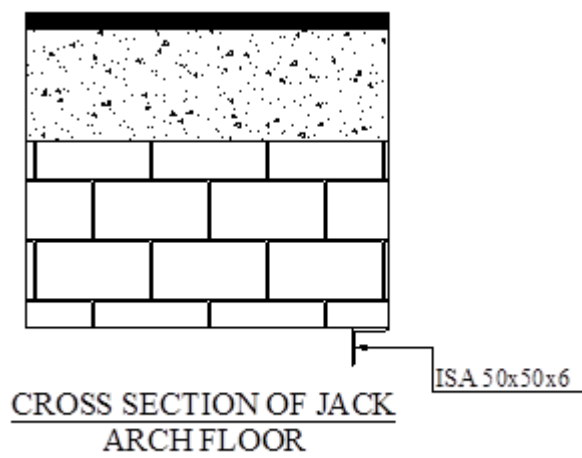
SKETCH II: SKETCH SHOWING CROSS SECTIONAL VIEW OF JACK ARCH STRENGTHENING SCHEME WITH ISA 50X50X6
