# Gap Analysis Between Macondo Deep Water Horizon Drilling Blowout With Regulations And Industry Standards & Codes

## Abstract

This paper presents case study based GAP analysis between technical regulations (namely, recommended practices, guidelines, Industry standards and codes that existed prior to the blowout) and the implemented design /operation in Macondo well.

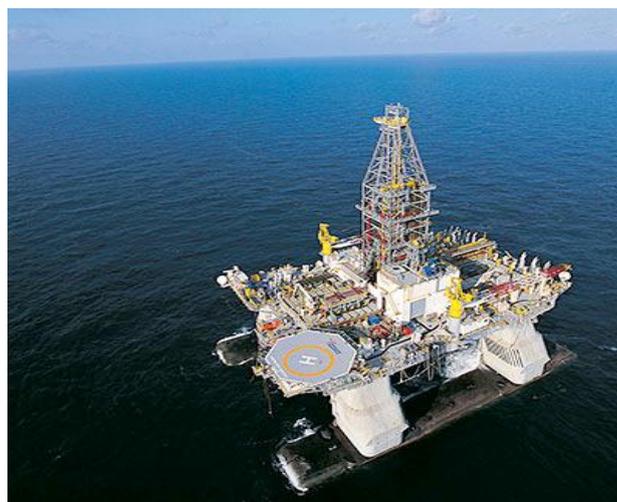
**Figure 1b:** Deepwater Horizon semisubmersible rig[1]

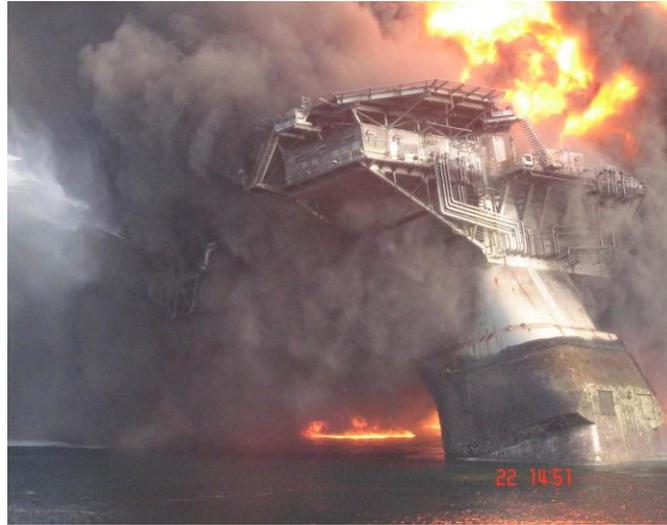
On April 20, 2010, a mile beneath the ocean disaster struck following a series of events in the world's biggest blowout (Figure 1c), causing 11 casualties and 17 were greatly injured. Thirty six hours later the fire and explosion on the rig caused the rig to sink to the sea floor. A huge amount of hydrocarbon spilled from the reservoir into the ocean, which lasted for 87 days and damaged fauna and flora (Figure 1d). The environmental impact of the blowout in the Gulf of Mexico is still being discussed and researched. The incident also traumatized the livelihood of many people.

**Figure 1c:** Macondo Well Blowout [1]

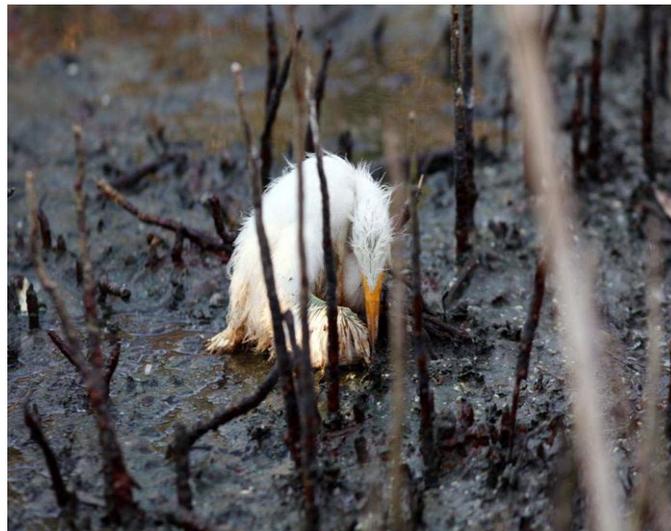
**Figure 1d:** Environmental impacts on fauna and flora[1]
