Effect of corrosion of reinforcement on the fatigue life of the high performance concrete beams

1. Abstract

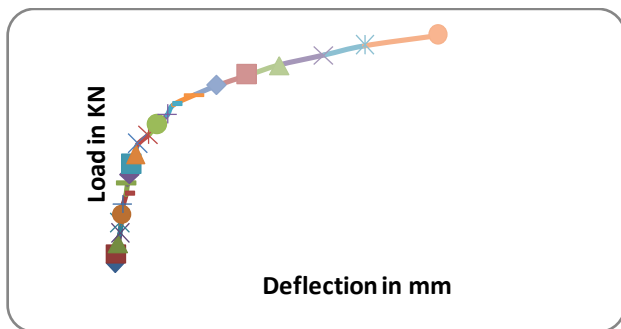
Fig. 3 Load-Deflection curve for static loading

At first a control beam R0 was tested under static loading. The ultimate load carrying capacity or load at failure was noted. It was 56.41 kn. Figure 3 shows the load-deflection curve of the beam tested under static loading. The trend of the curve is normal and the area below the curve indicates the energy absorption by the beam.

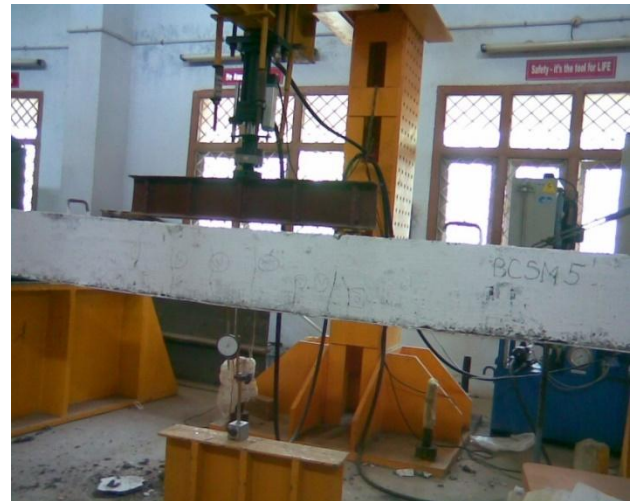
One control beam was tested under cyclic loading. Figure 4 shows the experimental set up for cyclic loading. The time series of the cyclic loading is given in Table 3.

Fig. 4 Experimental set up for cyclic loading
 The load imposed on each beam and the experimental results (deflections at failure) are given in the Table 4

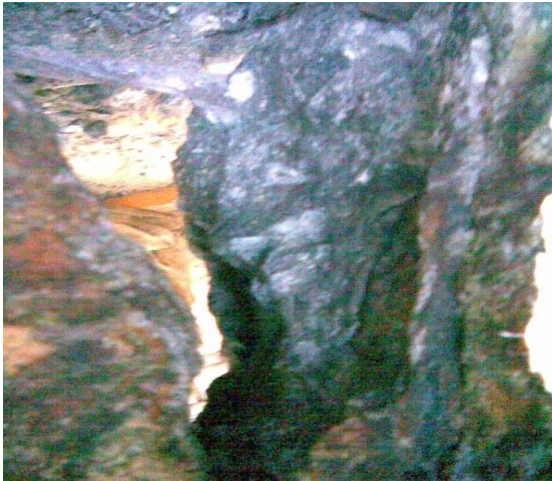
Fig. 6 The failure pattern and the effect of corrosion

The load imposed on the corroded beams was increased over the control beam by 25-35%, the cyclic life is decreased by 92.5% and 98%. It shows that an increase in load on the corroded beams reduces the number of cycles of the beam and it is not relative change. It can also be explained further that the slope of the stress-strain curve decreased with increasing degrees of corrosion damage level thereby it indicated the gradual reduction in the stiffness of the corroded beams. This indicated that the failure of beams was brittle in nature at higher degrees of corrosion. The ultimate strain is also reduced with increase in percentage of corrosion. But all the beams show same pattern of strain curve, i.e., step type. The ultimate deflection of the beams, decreased with increasing reinforcement corrosion level, leading to a reduction in ductility of the beams. The decrease in ductility was found to be 23.65 and 63.49%, respectively for beams subjected to 10 and 25% corrosion damage level. The crack propagation was observed along the reinforcement before loading but the failure was not observed along the reinforcement.
