Rutting Failure on Pavement Layers along Timboroa to Eldoret Road Section in Kenya

ABSTRACT

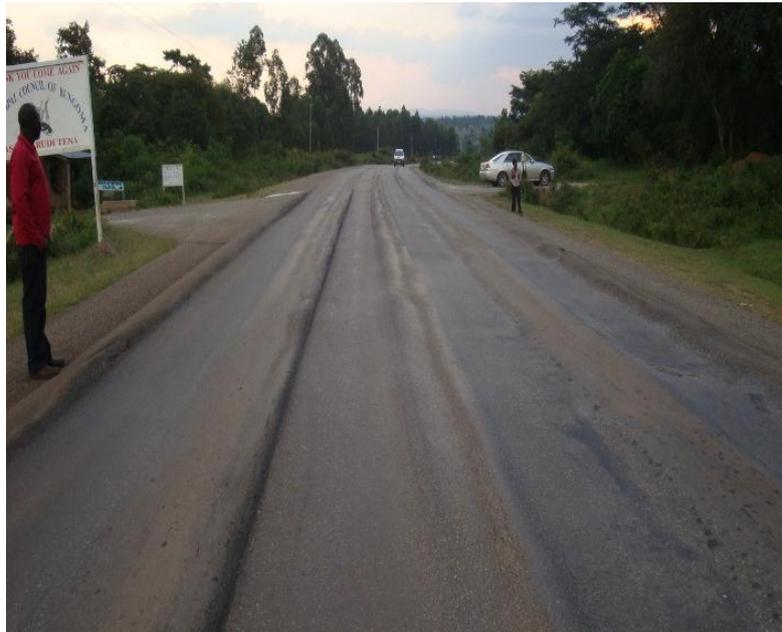
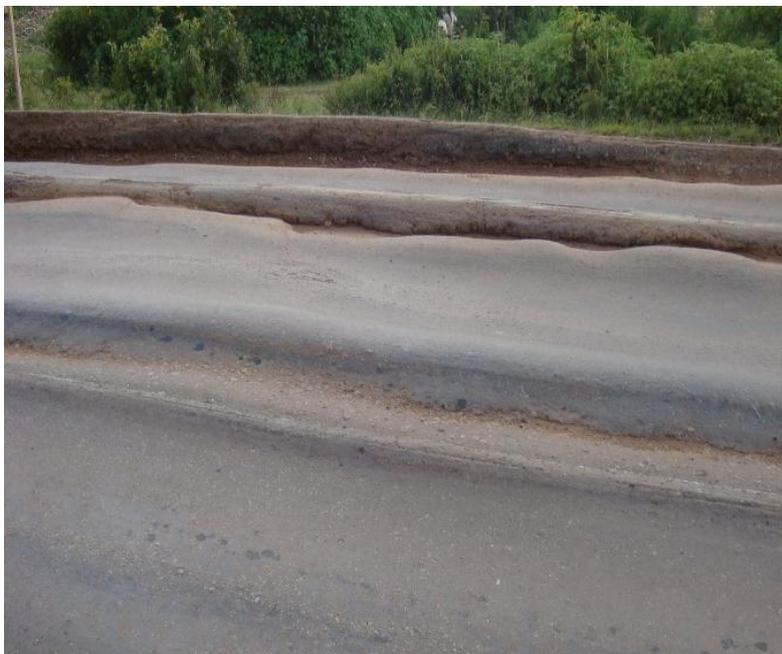
Plate 1: Severe rutting observed along the road section

The stability of the pavement layers and more so the subgrade layer relies immensely on the drainage conditions of an area (Salama 2005). A poorly drained soil will cause the water table to raise and therefore affect the subgrade layer which is the foundation. It is observed that rutting was prevalent in the well-drained sections as well as those that are moderately well drained. This means that the drainage condition did not play a significant role on the development of rutting on the road section. Apart from a few swampy areas observed around Timboroa and toward Eldoret town, it is imperative that the ground water table was apparently deep and therefore not significantly affecting the road pavement. The rutting failure as shown in Plate 1 was so severe in some sections not necessarily with drainage problems but dictated by other factors (Waweru et.al 2016).
