Structural Characterization and Seismic Vulnerability Analysis of Buildings Located in the Historic Center of Sincelejo

Abstract

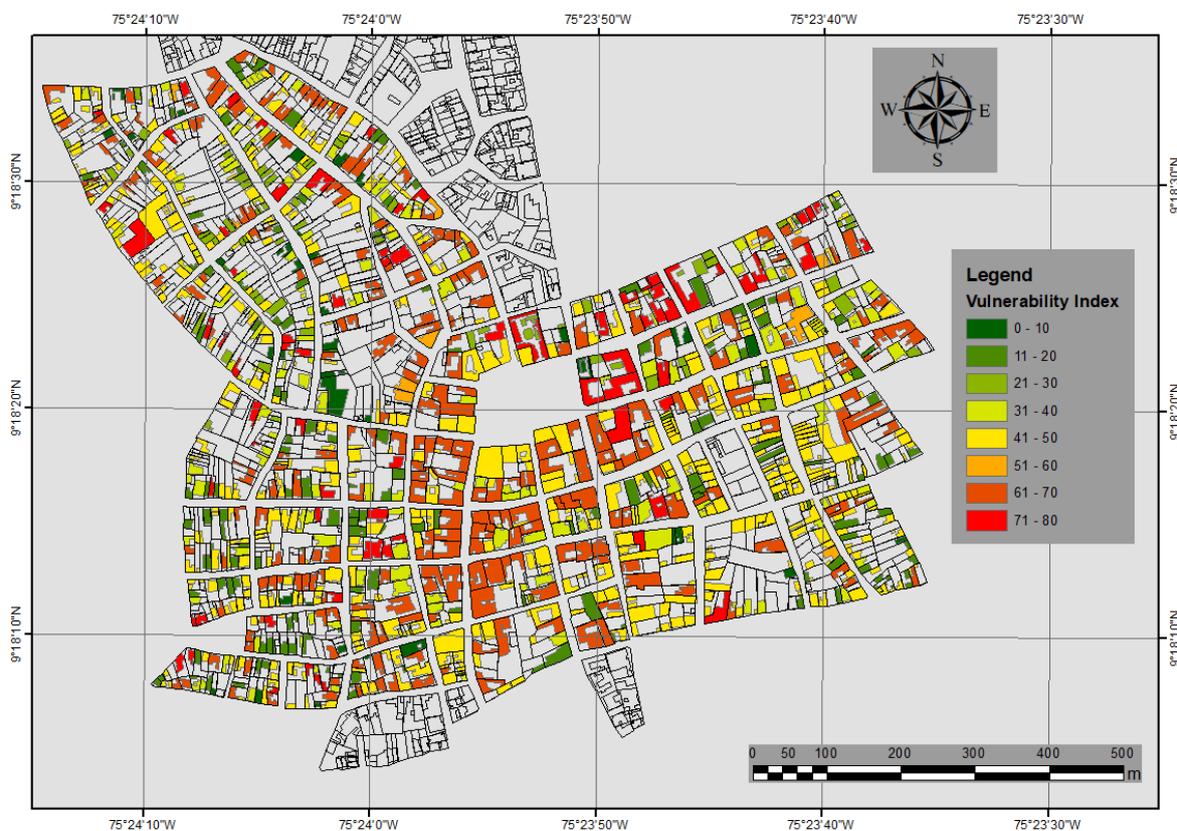
Fig. 6. Vulnerability Index of the buildings

Fig. 6 presents the Seismic Vulnerability Index calculated for the buildings in the historic center, and Fig. 7, Fig. 8, and Fig. 9 show the possible seismic damage scenarios of the buildings for accelerations of 0.065, 0.125 and 0.150, respectively.
