Current Situation and Issues Regarding the Accessibility of Beijing Daxing International Airport — Beijing Daxing International Airport Opened in September 2019

Located 50 km south of the heart of Beijing, Beijing Daxing International Airport opened in September 2019. The objective of this paper is to discuss barriers in the accessibility of the elderly and people with disabilities at the airport based on the result of field investigation.

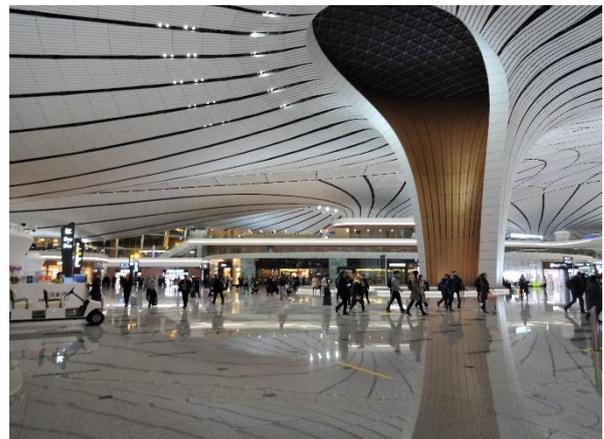
- No guidance blocks were found within the restricted area for domestic flights (Photo 1). Alert blocks are installed only in selected areas such as in front of multipurpose bathrooms. This may be appreciated in terms of not interfering with the people on wheelchair, cane users, and the people carrying roller case, however, as a precondition, there should be guide-helpers accompanying the visually impaired.

Photo1. Domestic restricted area

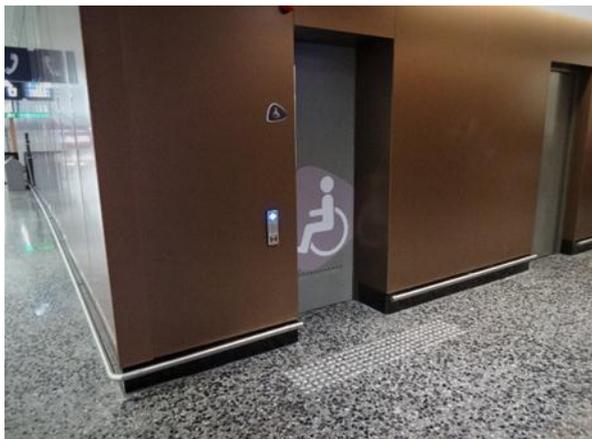
There are metal warning blocks installed in front of doors to all multipurpose bathrooms within the restricted area which are being barriers for the people on wheelchair trying to get in the bathroom (Photo 2). In those bathrooms there are urinals with handrail (Photo 3) that is supposedly intended to be used by the visually impaired. As a reason for that presumption, there are no urinals with handrail in the men's room near the multipurpose bathroom (Photo 4). The urinals with handrail are often used by cane users and the visually impaired. It is a worldwide rare case to find urinals with handrail installed in multipurpose bathrooms intending to be used by cane users and the visually impaired.

Photo2. The door of multipurpose bathroom within the restricted area

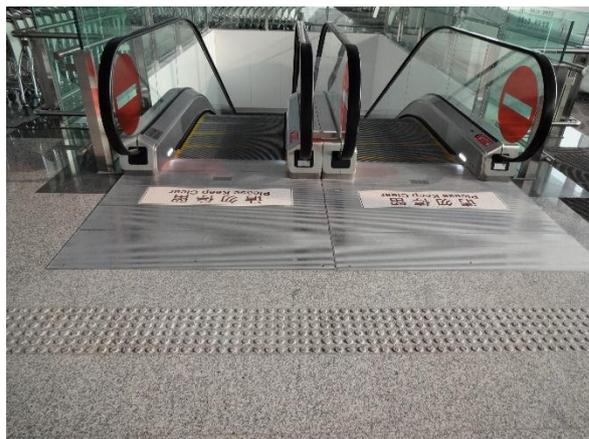
- Outside the restricted area, there are warning blocks installed in front of escalators (Photo 5), staircases (Photo 6) and elevators (Photo 7). There are also guidance blocks in front of elevators, but the purpose of that installation is not clear (Photo 8). Alert blocks are installed extending the full width of the elevator door, which is being a barrier for other users.

Photo5. Guidance blocks in front of escalators

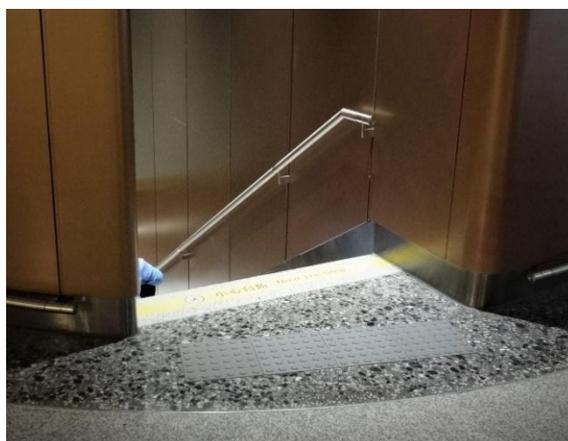
Photo6. blocks in front of staircases

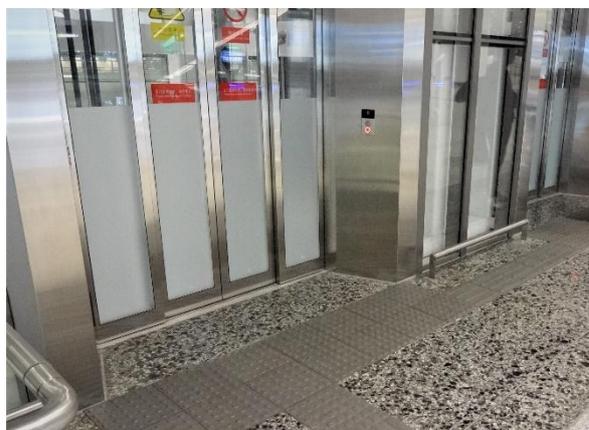
Photo7. Tactile walking surface indicators in front of elevators

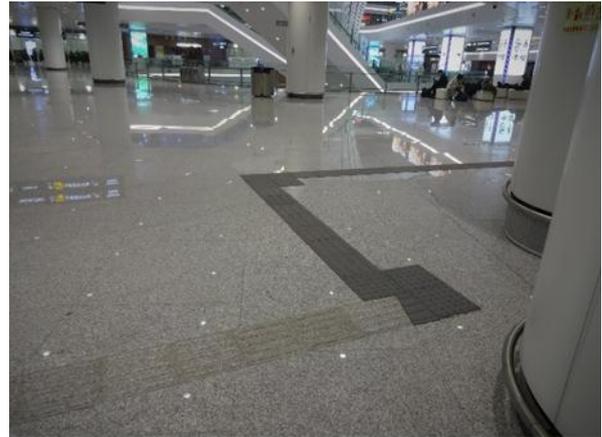
Photo9. Guidance blocks installed on the third floor

There are guidance blocks installed on the third floor (Photo 9), where departure gates for domestic flights are located, while there are no such blocks installed almost anywhere on other floors. There is a mixture of guidance blocks of the same color with the floor surface and black vinyl chloride adherence-type guidance blocks. The black blocks have high visibility, but mixing different types of blocks may cause landscape issues.

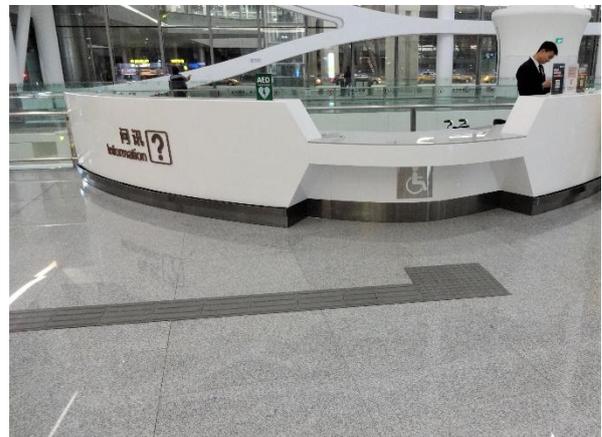
On the ground floor with entrance/exit to taxi stands, there are black adherence-type guidance blocks leading to the information booth (Photo 10). There are door mats found placed on the blocks at entrance/exit of the airport (Photo 11). We have seen this kind of situations all over the world, but it is a shame to see the same situation at several locations in this brand new Beijing Airport.

Photo10. Blocks leading to the information booth

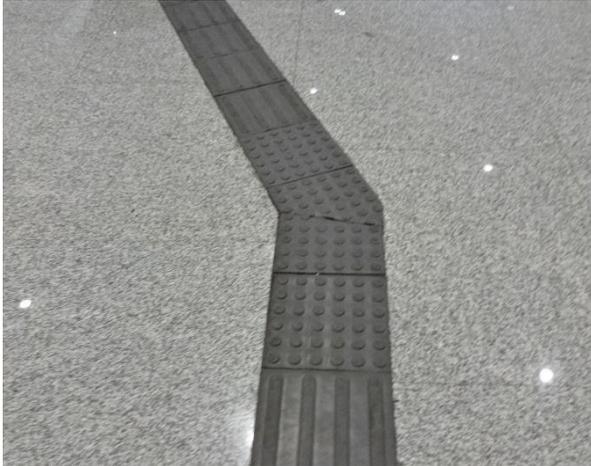
There are unnecessary warning blocks found on the ground and the third floor (Photo 12). In places where the curve section for guidance blocks is less than 145 degrees [9] , there should be warning blocks installed. However, if the angle is greater than 145 degrees, the visually impaired rarely notice the curve or even if they notice the curve they would rarely get confused. The installation of warning blocks in this case would rather

lower the efficiency of their walking significantly because they would have to stop and search the direction.

Photo12. Unnecessary warning blocks

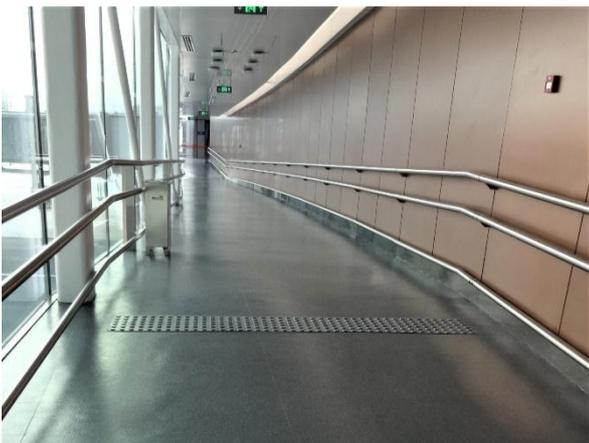
Photo13. Warning blocks installed at the beginning and the end of the slope from boarding gate to boarding bridge

- There are almost no slopes or stairs in the airport. The airport is designed for the passengers to use elevators or escalators when they are going up/going down. There is a gradual slope in the path from boarding gate to boarding bridge. At the beginning and the end of that slope there are warning blocks installed in a row (Photo 13). The visually impaired passengers would need human assistance at this particular location in the first place. These warning blocks are not only unnecessary but also interfering other pedestrians, thus they should be removed.

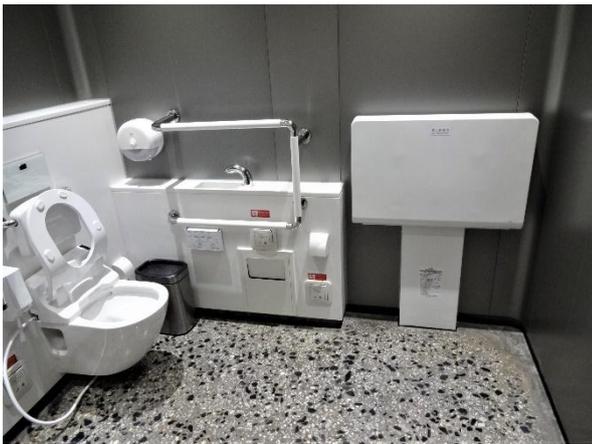
Photo14. Equipment of multipurpose bathroom 1

- In spite of the installation of warning blocks in front of multipurpose bathroom doors within the restricted area, which could be an obstacle, the bathroom interior is well equipped. The toilet seats are equipped with movable handrail and back support while makeshift beds (Photo 14), ostomate equipment, urinals equipped with handrail, as well as wash-basin for the people on wheelchair (Photo 15) are available. In addition, there are large emergency buttons placed at several locations where the people on wheelchair or those fallen on the floor may reach to ask for a help in case of emergency (Photo 16).

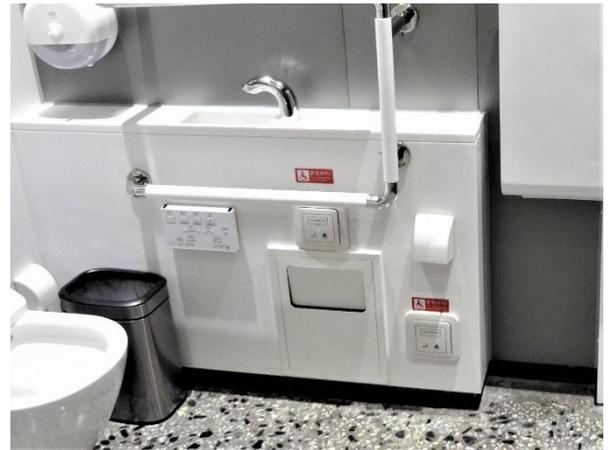
Photo16. Equipment of multipurpose bathroom 3

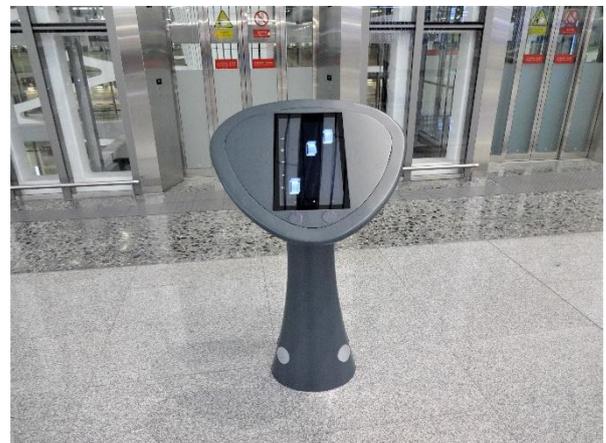
Photo17. Equipment to centrally control three elevator cars at once

- There are a number of elevators in the airport, which are large and comfortably usable even with a wheelchair. Besides small car call buttons placed for individual elevator, there is an equipment to centrally control three elevator cars at once (Photo 17). Passengers may call an elevator by pressing a large button below the screen or pressing white round button located at the bottom of the support post of the equipment with their foot (Photo 18). The screen can be viewed clearly even from the visual line on wheelchair (Photo 19).
- However, the equipment is independently installed in front of the elevator, which should be no doubt an “obstacle” for the visually impaired.

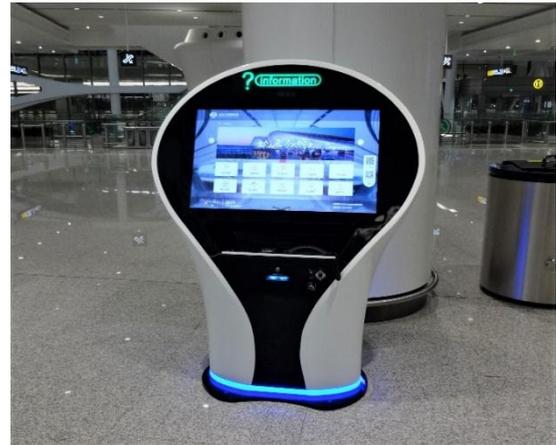
Photo22. Informational guidance provided through screen display on a large equipment

- Informational guidance in the airport is mainly provided through screen display on a large equipment (Photo 22), but it is also available to get information by using telephone as well as call buttons for the disabled (Photo 23).

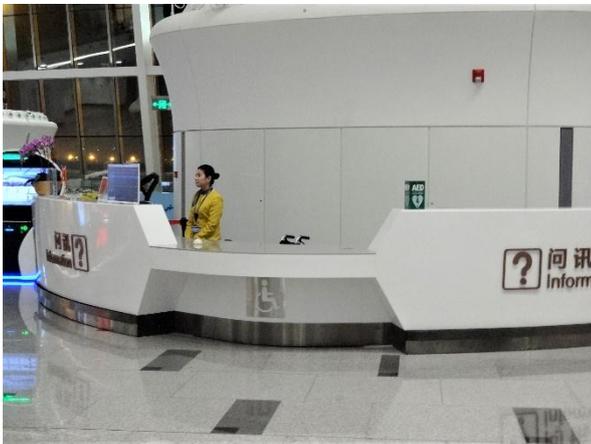
- There are desks with appropriate height for the people on wheelchair (Photo 20) provided at information booth on each floor. There are no Tactile walking surface indicators installed except for the information booth on the ground floor. Desks of appropriate height for the people on wheelchair are also provide at a money exchange counter (Photo 21).

Photo20. Information booth

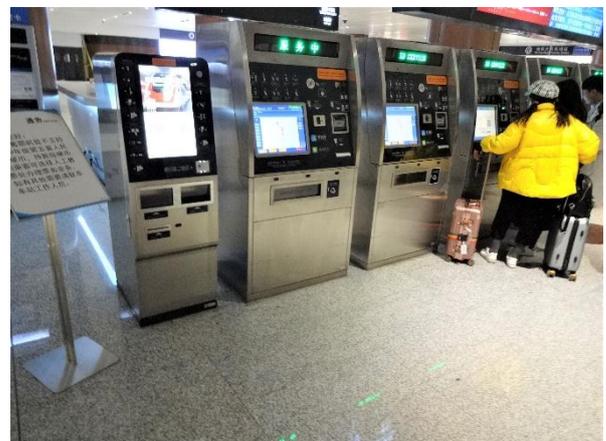
- The ticket machines are not usable for the people on wheelchair and the visually impaired (Photo 24). They need to ask a subway employee nearby to take them to a ticket sales office to buy tickets in person.

Photo24. Vending machine for subway tickets

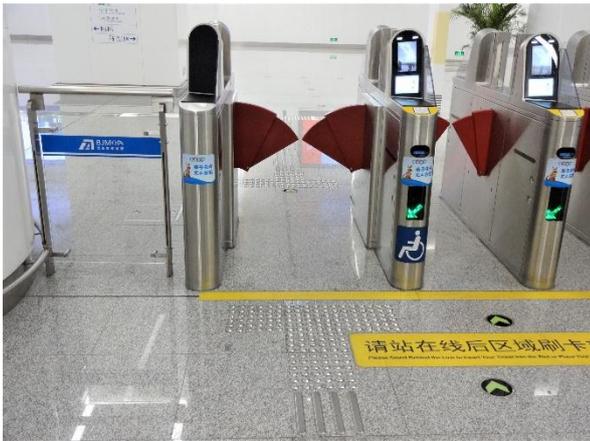
- The entrance gate to subway platform is an automated type. Tactile walking surface indicators are installed along the same booth that is used by wheelchair users (Photo 25), which is a fundamental mistake in a sense

that tactile walking surface indicators are being obstacle for the people on wheelchair.

Photo25. Entrance Gate to the subway platform

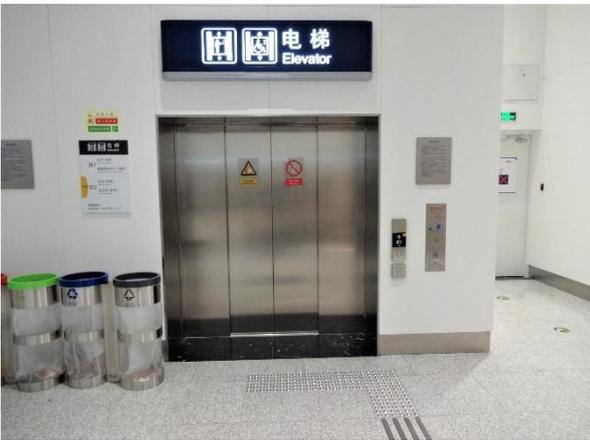
Photo26. Elevator of the subway station (second basement level)

- There are guidance blocks installed leading to the platform. An elevator carries passengers going to the ticket gate (first basement level) from the subway platform (second basement level) (Photo 26). There are buttons for the people on wheelchair to use as well as Braille in the elevator (Photo 27). Those who take this elevator and get off on the first basement level arrive at a place indicated in the Photo28. There are no Tactile walking surface indicators here. We are only stunned to see such inconsistent barrier-free facility.

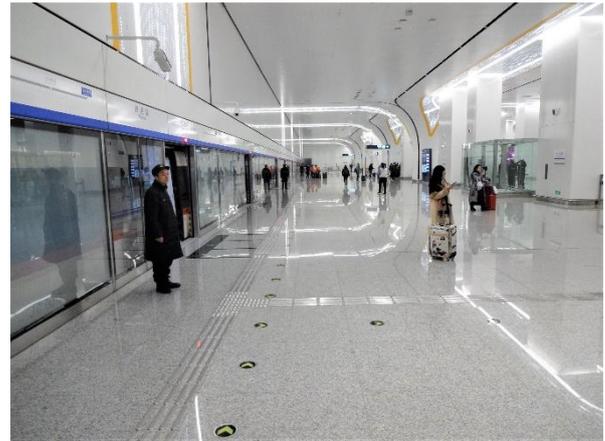
Photo30. Subway station platform 2

- There are guidance blocks and warning blocks installed on the platform. The warning blocks are placed around the platform screen doors opening/closing area used by passengers getting on and getting off the subway (Photo 29). There are no Tactile walking surface indicators installed around the area of entering/exiting subway, so there are no obstacles for wheelchair users. In addition, the platform is quite large (Photo 30).

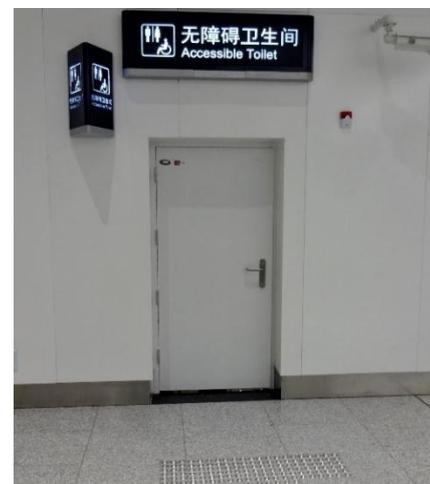
- There is a multipurpose bathroom outside the ticket gate in the subway station (Photo 31). Although there are Tactile walking surface indicators installed, there is quite a distance from the bathroom door. The biggest problem of this bathroom is that the door can be opened only by moving down and pulling the door knob located at a high position. It is impossible for the people on wheelchair to use this bathroom independently.

Photo31. Entrance of the multipurpose bathroom at subway station

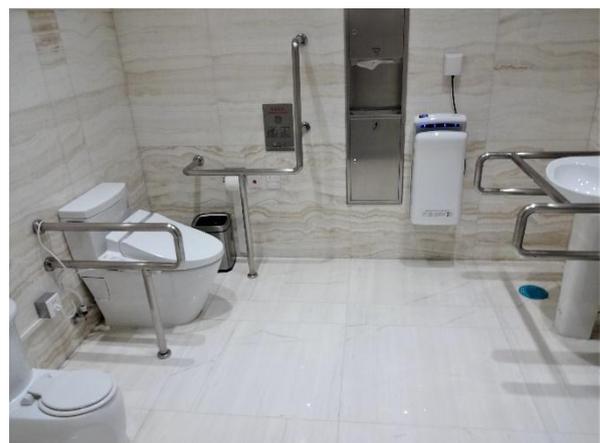
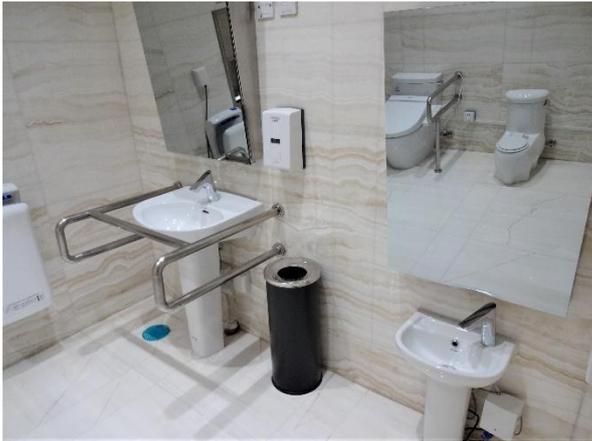
- The bathroom interior is equipped with minimum necessities except for toilet seats for small children, but there are other problems. Firstly, the emergency buttons are wrongly located and the number of the buttons installed is not sufficient. Secondly, there is a fixed handrail awkwardly located near the toilet paper holder making it difficult to reach the paper. Thirdly, the paper towels as well as hand dryers are placed too high, making it difficult for the people on wheelchair to use (Photo 32, 33).

Photo32. Inside of the multipurpose bathroom at subway station 1

Photo33. Inside of the multipurpose bathroom at subway station2

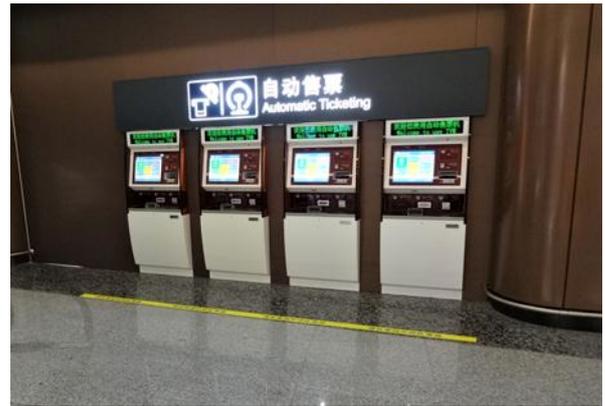
- The ticket sales office in the high-speed railway station is not barrier-free (Photo 36). There is a security check point before entering the waiting area of the station. Passing that security check point, there is a manned service counter, where passengers can buy tickets (Photo 37). Foreigners and people with disabilities are supposed to buy tickets here at the counter.

Photo36. Automatic ticketing for high-speed railway train

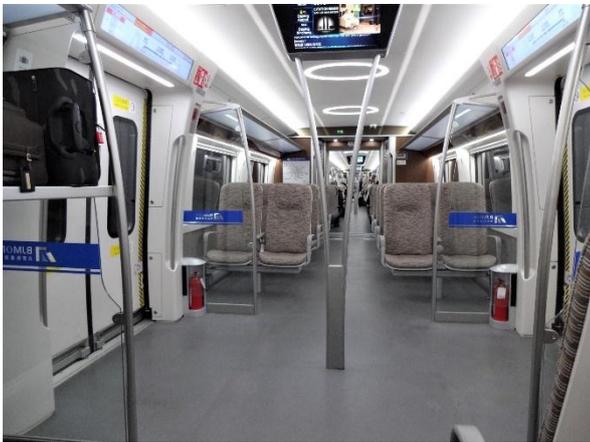
Photo34. Inside of subway vehicle

- Looking at the interior of the subway vehicle in Photo34, there is a large space near the door. But the depth of priority seats, that are provided two per

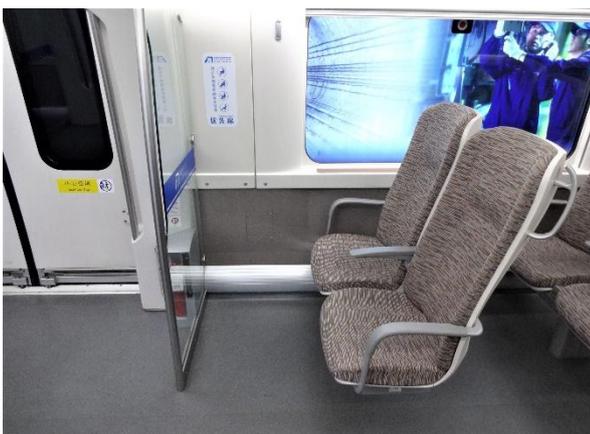
vehicle, is the same as other seats (Photo 35).

Photo35. Priority seats of subway vehicle

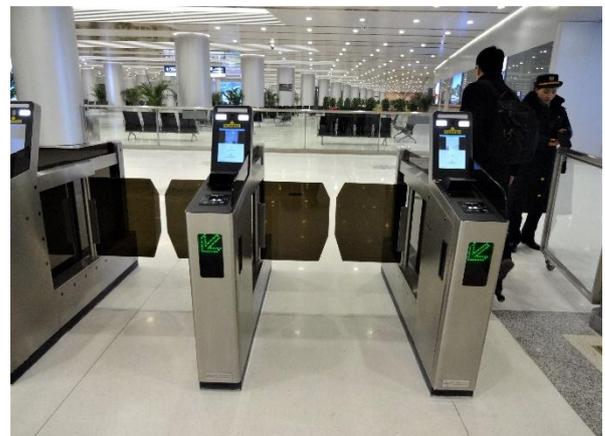
Photo38. Gate to platform in the high-speed railway station

- Passing the automatic ticket gate shown in Photo 38, passengers go down to the platform on the second basement level by elevator or escalator. Although the waiting room in the high-speed railway station is large, there are no Tactile walking surface indicators nor guidance blocks leading to the ticket gate (Photo 39).

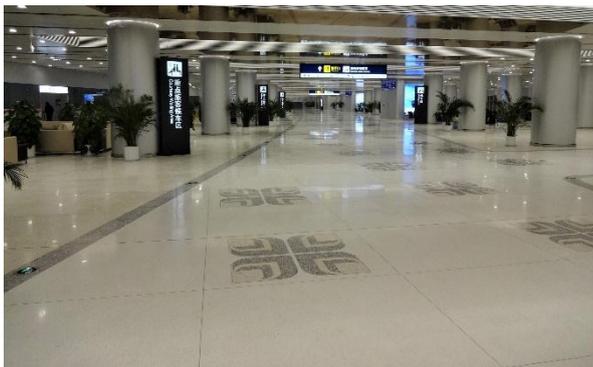
Photo39. Waiting room in the high-speed railway station

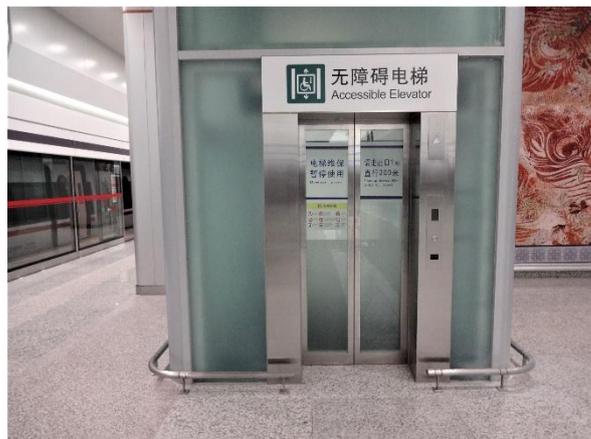
- There are platform screen doors installed on the platform of the high-speed railway station along with warning blocks which are 50 cm wide (Photo 40). The locations of the platform screen doors and the vehicle doors are not aligned that may cause significant confusion for visually impaired passengers (Photo 41). There are no Tactile walking surface indicators in the elevator transporting passengers from the platform level to the ticket gate level nor push buttons that the people on wheelchair may reach (Photo 42).

Photo42. elevator on the platform level

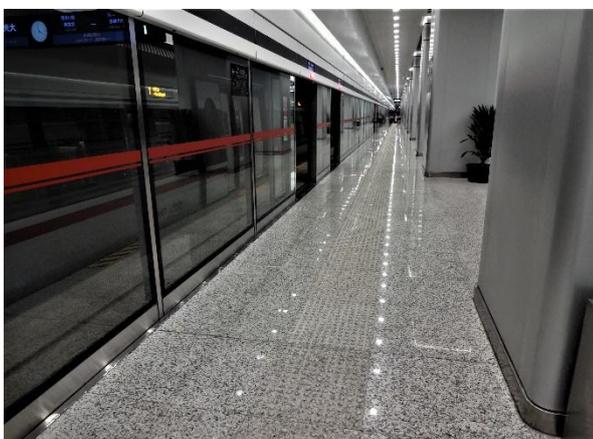
Photo40. Platform in the high-speed railway station 1

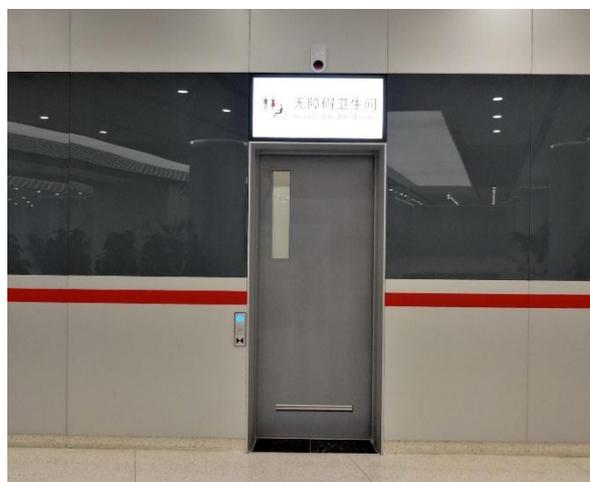
- The entrance to the multipurpose bathroom in the high-speed railway station is too narrow for wheelchairs (Photo 43). There are no Tactile walking surface indicators installed, either.
- There are minimum facilities provided inside the bathroom, but there are also problems. Firstly, there are no toilet seat back supports. Secondly, paper towels are placed too high. Thirdly, there are no ostomate facilities. And finally, the handrail on the left side of the toilet seat is too far from the seat (Photo 44, 45). There are urinals equipped with handrail. Urinals with handrail are provided in regular men's room as well (Photo 46), which is a difference from the men's room in the restricted area.

Photo43. Entrance to the multipurpose bathroom in the high-speed railway station

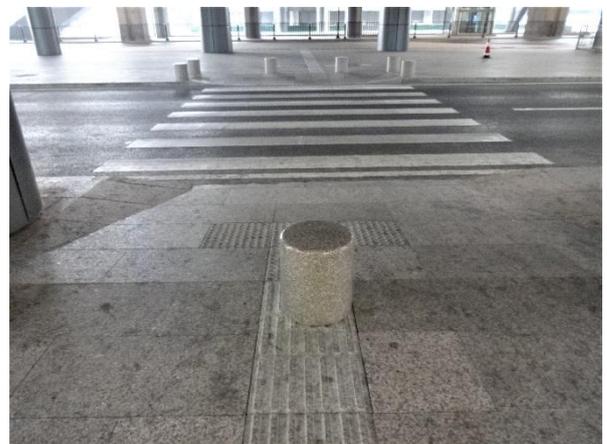
building (Photo 48). There are car stops placed on the guidance blocks leading to a pedestrian crosswalk, which are dangerous barriers for the visually impaired (Photo 49).

Photo49. Outside the building2

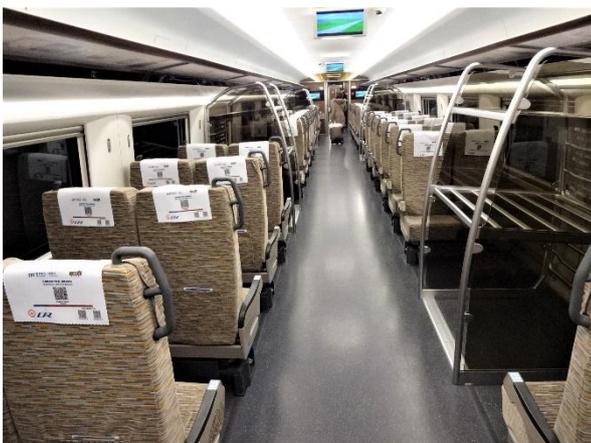
Photo47. Interior of high-speed railway vehicle

- The seats are all reserved. The vehicles have wide aisles (Photo 47).

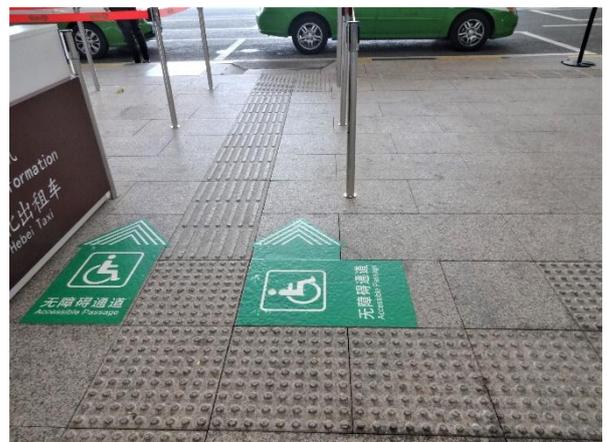
- There are Tactile walking surface indicators around the taxi stand and also in front of the taxi counter (Photo 50). The Tactile walking surface indicators in front of the taxi counter should be unnecessary because there is always somebody at the counter who is able to help the visually impaired to get a taxi. The Tactile walking surface indicators in this area are rather obstacles for wheelchair users to pass through. It is marked as "Barrier-free passageway" on the floor, but it is a wrong sign because the Tactile walking surface indicators become barrier for wheelchair users.

Photo50. Taxi stand

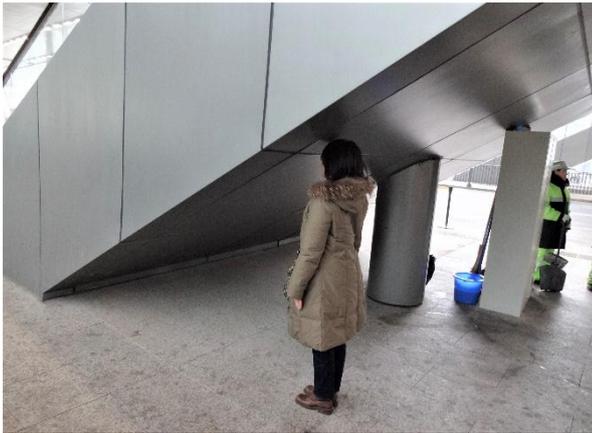
Photo51. Under the stairs outside the airport building

- The areas below staircases and escalators are usually dangerous for the visually impaired with a risk of bumping their head against. Typically, there should be rails or pylons placed to avoid such accidents. There are very little countermeasures of the sort taken in this airport (Photo 51).

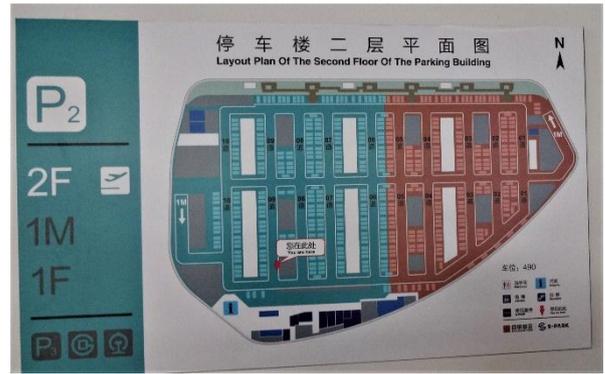
As there are no signs on the map in the parking lot, people would have no clue to find disabled parking space (Photo 54). There are some overhead signs along the vehicle route including a wheelchair mark (Photo 55).

Photo54. Map of short-term parking lot

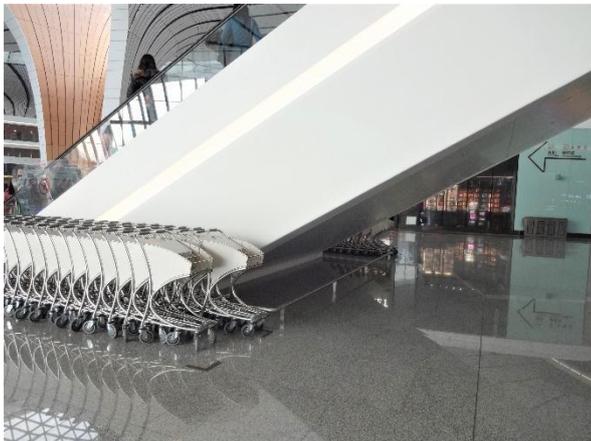
- There is a small rail installed below staircases in the restricted area, but before the feet or canes of passengers get there, they would bump their head (Photo 52).

Photo52. Under the stairs in the restricted area

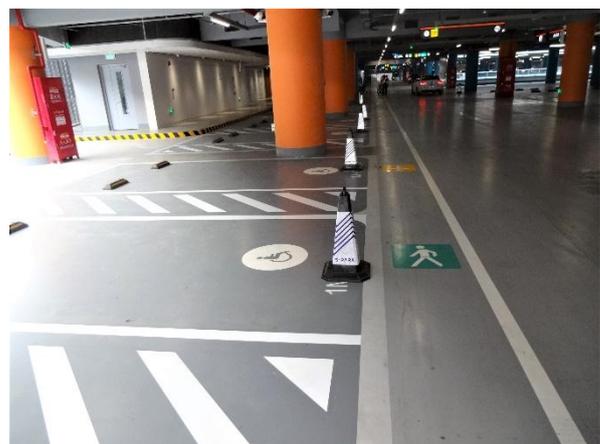
- There is disabled parking space for 18 vehicles in one of the parking garages. It is hard to find even coming closer because there are no wall signs or hanging signs at all except some small signs on the floor (Photo 56). Besides, there are pylons placed, so it is highly likely drivers with disabilities are unable to use the space.

Photo56. Parking space for the disabled

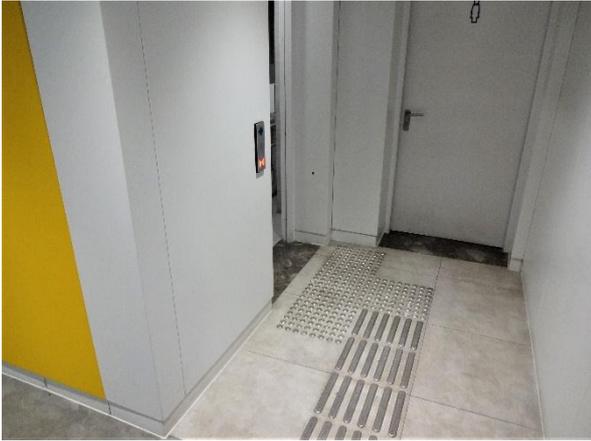
- There is a multipurpose bathroom near the parking lot (Photo 57). The door can be opened with a push button, but the bathroom is small in width, and there are a lot of Tactile walking surface indicators installed in front of the door inhibiting entrance to the bathroom without taking a right-angled turn. The bathroom is absolutely full of barriers.
- There are minimum facilities provided in the bathroom (Photo 58). But problems are that paper

Photo57. Multipurpose bathroom in the parking lot

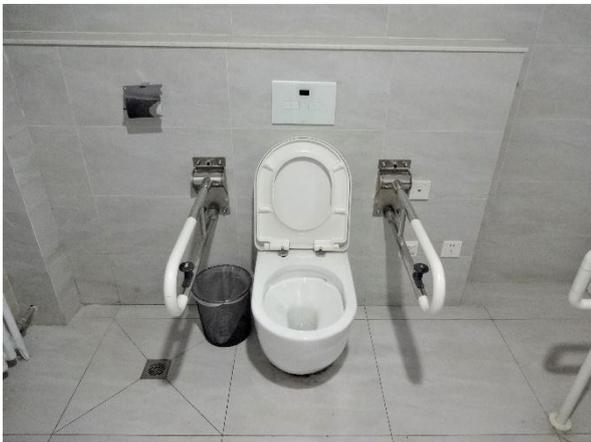
holders are placed too high which may not be reachable by wheelchair users and that there is only one emergency button. As a noteworthy merit to point out, the toilet seat is centrally placed so that users with paralysis on either side of the body may transfer their body to the toilet seat using the handrail.

Photo58. Inside of the bathroom in the parking lot

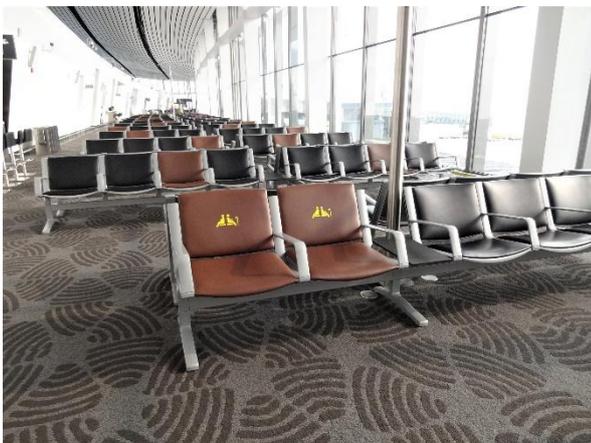
- There are only two priority seats near the boarding gate in the waiting area, which is far too few (Photo 59).

Photo59. Priority seats near the boarding gate in the waiting area
