Physico-chemical Properties and Heavy Metal Contents of Ino-Capayang Mine-made Lake in Marinduque, Philippines

Abstract

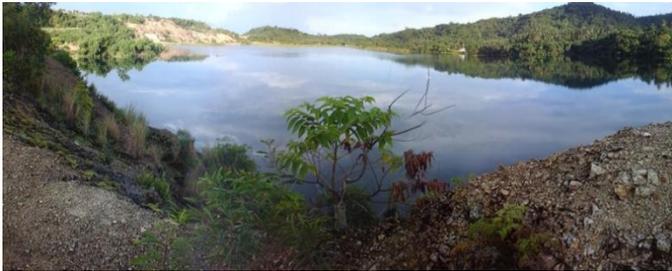
Fig. 1. Ino-Capayang mine-made lake filled with water.
