Comparative Study of Impact Properties of Coir & Aloe Vera Based Composites With GFRP

This study compares the use of Coir & Aloe vera fibre composites and that of GFRPs for use in bumpers in automotive applications. White Coir was chosen because of its excellent anti-weathering property and high strain to failure. A multi-fibre composite was devised by blending both Aloe vera and coir and weaving them to form a bi-directional mat. Other samples contained pure Coir and pure Aloe vera, both in randomly oriented mats and bi-directional mats. Before composite fabrication, the fibres were subjected to chemical modification using NaOH, to decrease water absorption. They were reinforced in a matrix of Polypropylene / Polyester. The fabricated natural fibre composite samples along with GFRPs were subject to impact testing by un-notched Charpy Impact test. SEM analysis was carried out on the fracture surfaces of impact samples.

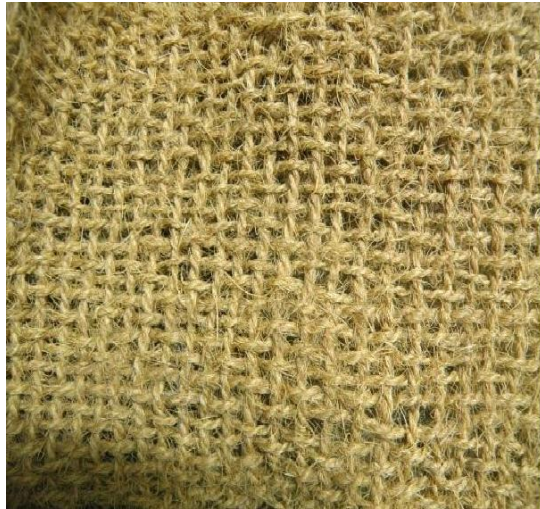
Figure 1: Woven mat – Coir (Bi-directional)

The spun yarn was then woven into mats of size 1000 mm x 200 mm x 3 mm. Three different types of mats were woven, viz. Coir–Coir (Bi–directional), Coir–Aloe (Bi–directional), Aloe–Aloe (Bi–Directional) as shown in the Figures 1, 2 and 3 respectively. The entire process was done manually using handlooms. The woven mats were then cut to the required dimensions during composite fabrication.

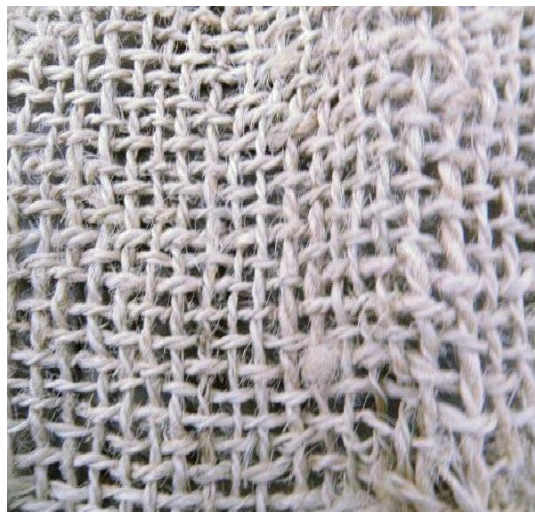
Figure 2: Woven mat – Aloe Vera (Bi-directional)

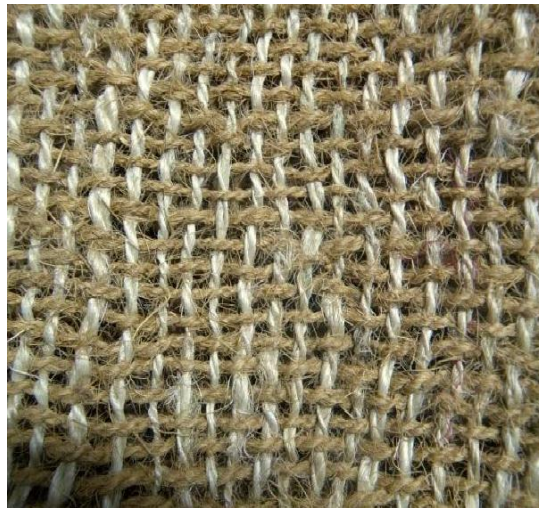
Figure 3: Woven mat – Coir / Aloe Vera (Bi-directional)

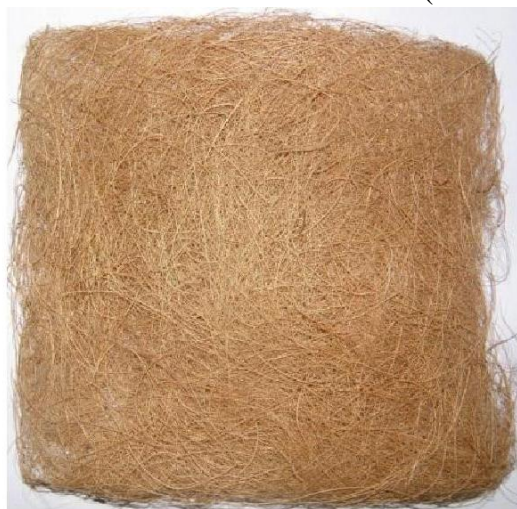
Figure 4: Random mat – Coir

The random fibres were fabricated manually by hand-rolling which is shown in Figure 4. Care was taken to ensure uniformity of the random mats and avoid lumping of fibres. The fibres were then treated with 10% NaOH, in order to ensure better fibre-matrix interaction and thus reduce moisture absorption. The fibres were soaked in 10% NaOH for 12 hours, then rinsed in distilled water to remove traces of the chemical and then sun-dried.

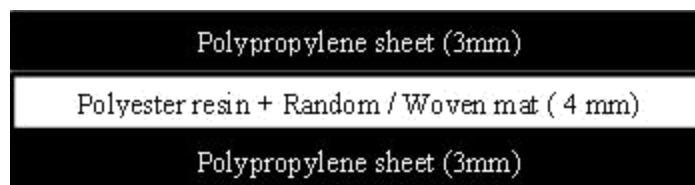
Figure 5: Cross-section view of composite plate

The composite composes of two matrices; polypropylene and polyester. With respect to being used in the bumper, the following properties of PP are attractive viz., high fracture toughness, ability to be coloured, dirt and dust resistant, corrosion resistant, resistant to temperature fluctuations, resistance to fatigue. And, Polyester was chosen because it can be derived from natural sources such as cuticle of plants and hence are bio – degradable. They have excellent durability and low water absorption. The schematic representation of composite lamination is shown in Figure 5.

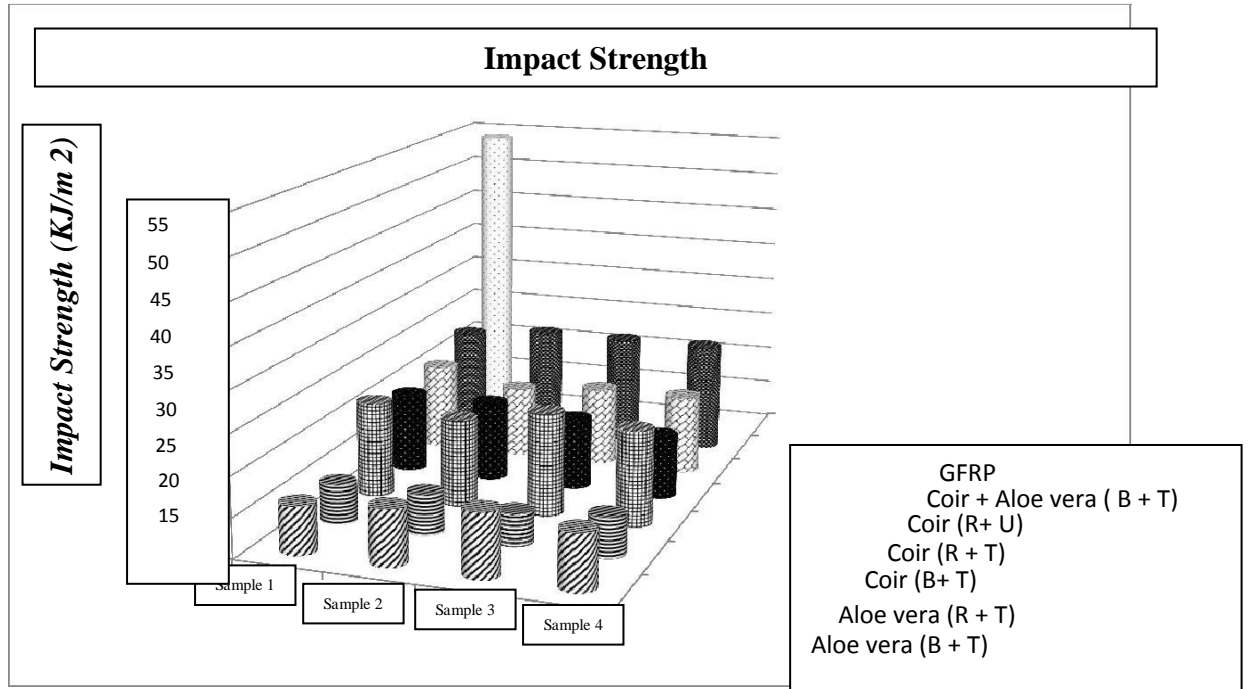
Figure 6: Impact Strength

The graphical representations of impact strength and specific impact strength for various composites are shown in figures 6 and 7. Similarly the impact strength and specific impact strength values for various composites are listed in Table 2 and Table 3. Coir has poor bonding with the matrix and hence it has some micro-voids at the interface. When subject to impact loading, the impact energy is dissipated along the fibre – matrix interface leading to fibre–pull out or fibre debonding. During this process, a significantly larger amount of energy is up for creating a new surface at the fibre – matrix interface.

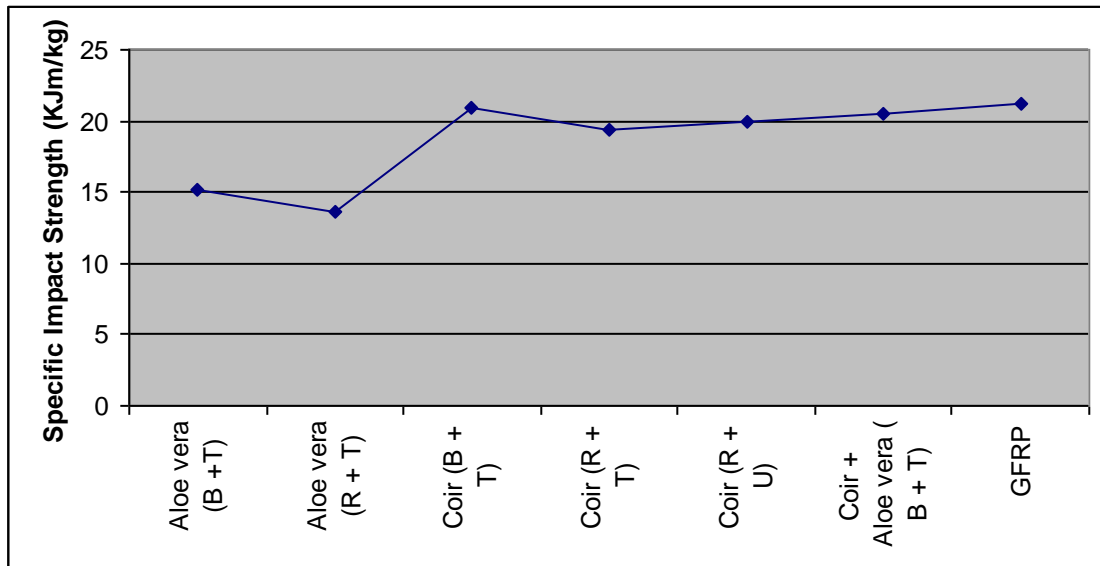
Figure 7: Specific Impact Strength

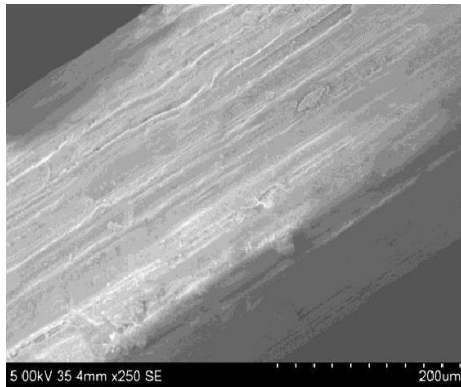
Figure 8: SEM micrograph of treated Coir fibre

The SEM images of the fractured surface of various composites are shown in Figure 8 to Figure 13. The fractured surface of the individual fibres is different. In Coir, it shows a serrated edge at the fibre tip, inclined to the fibre axis, whereas, the Aloe vera has a fracture surface which is almost perpendicular to the fibre axis. P. Wambua et al (2003) have stated that the serrated edge absorbs more energy during failure due to the propagation of the crack through a larger cross section area than if it failed normal to the fibre axis [11].

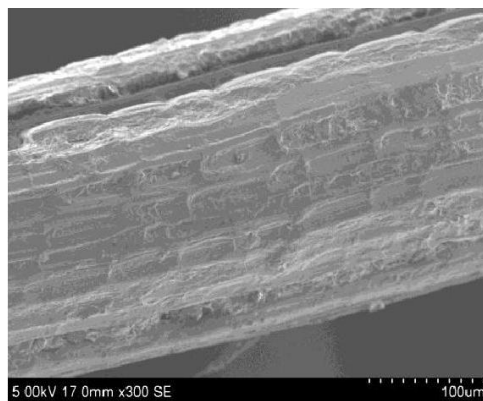
Figure 9: SEM micrograph of treated Aloe vera fibre

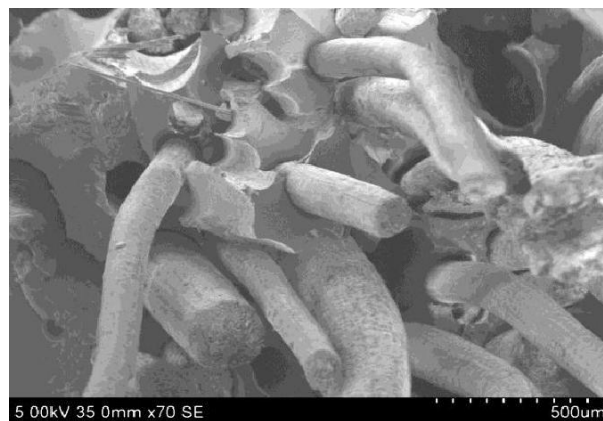
Figure 10: SEM micrograph illustrating vera fibre pull-out in Coir / Coir (Bi-directional) Composite

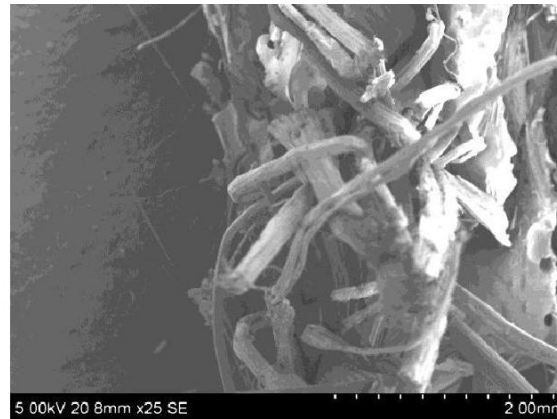
Figure 11: SEM micrograph of Aloe (random) composite showing interface debonding

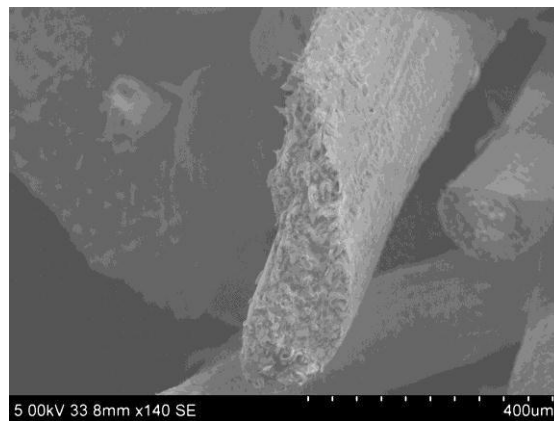
Figure 12: SEM micrograph of Coir fiber fracture surface

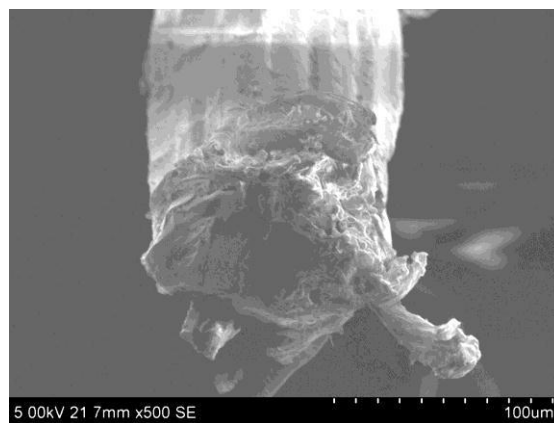
Figure 13: SEM micrograph of Aloe vera fibre fracture surface
