Performance of Heat Affected RC Beams after Repair

Abstract

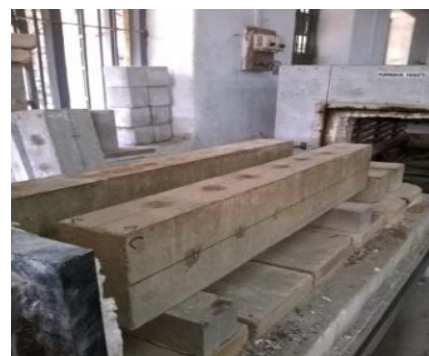
Fig. 2 (a) RC beam specimens before heating

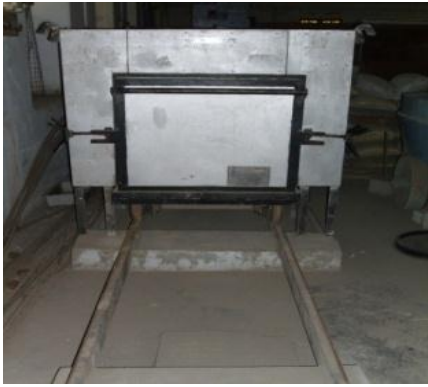
Fig. 2 (b) RC beam specimens in to the heating chamber

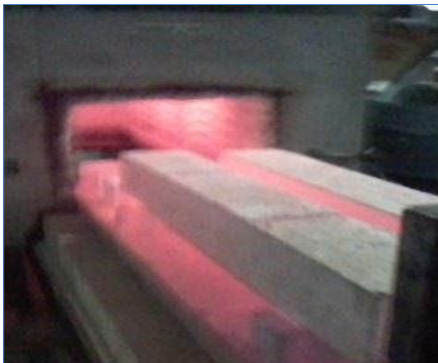
Fig. 2 (c) RC beam specimens after heating

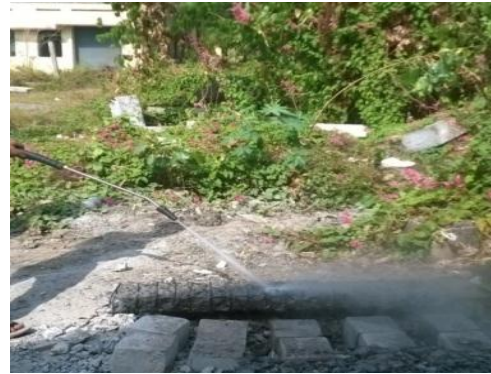
Fig. 4 High water pressure spraying

The original concrete cover was chipped off up to 15 mm thick to expose the existing reinforcing bars. Cleaning of the reinforcing bars preceded immediately using sand blasting equipment until all the reinforcing bars were to bare white metal finish as shown in Fig.3. High pressure water spraying was used immediately before epoxy application in order to remove all loose and defective concrete and for final cleaning of reinforcing bars. This utilized a 41.3 MPa high pressure washer as shown in Fig.4. The quality of bonding surface and rough texture was assured by this final surface preparation procedure. The tight spaces and reinforcing bar cages required Nitobond SBR latex epoxy application by hand brushing shown in Fig.5. It was therefore necessary to require that the epoxy would have an adequately long “overlay time” of at least six hours to allow application, erection of forms and pouring of concrete.

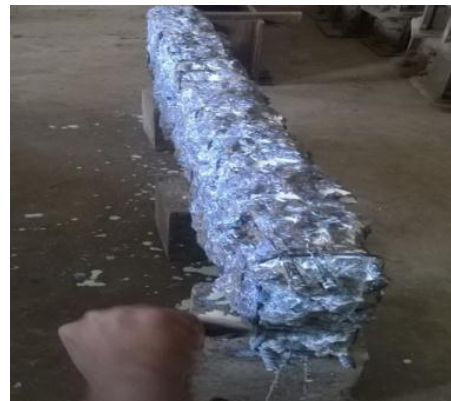
Fig.5 Applying epoxy resin

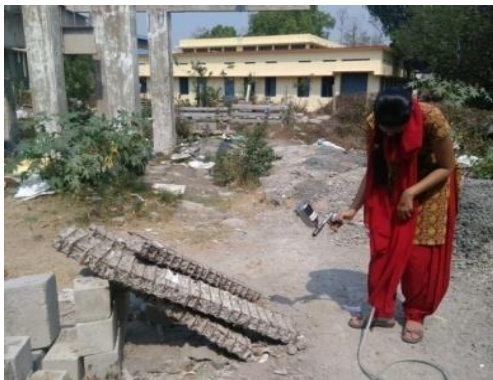
Fig. 3 Sand blasting of chipped beam

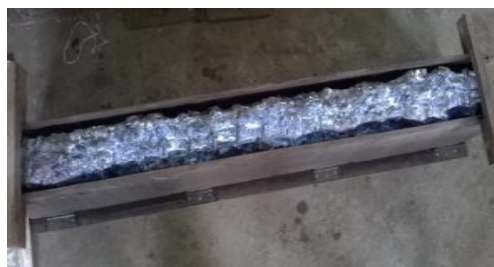
Fig. 6 Specimen placed in the mould

The 15 mm clear cover that is removed is again maintained using cover blocks inside the beam moulds at the bottom. Concrete layer of 15 mm thickness was laid on the bottom of the mould. After the primer is applied, the specimen is placed in the mould again as shown in Fig.6. Then the gap between the chipped beam and the mould was filled with concrete and repair material. Each layer was compacted using tampering rod. The surface was levelled with trowel and was marked for identification. The beam specimens were demould after 24 h of casting. The demoulded specimens were cured in a water tank for a period of 28 days and there after tested by rebound hammer and ultrasonic pulse velocity tester. Then the repaired beams are tested for ultimate failure load on a 100 ton Universal Testing Machine (UTM) with two point loading as shown in Fig.7.

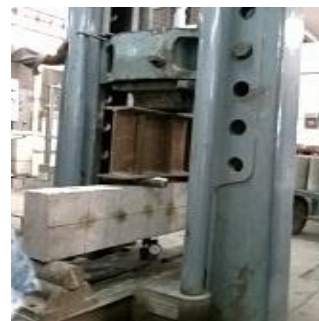
Fig. 7 RC repaired beam in UTM under two point loading

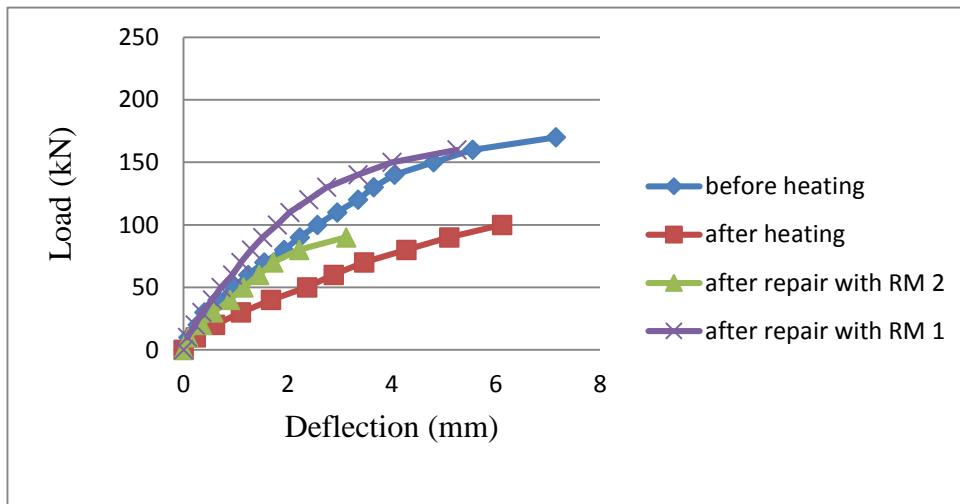
Fig.10 Load – Deflection behaviour of RC beam exposed to 100 °C

Fig.11 Load – Deflection behaviour of RC beam exposed to 200 °C

Fig.12 Load – Deflection behaviour of RC beam exposed to 300^oC

Fig.13 Load – Deflection behaviour of RC beam exposed to 400^oC

Fig.14 Load – Deflection behaviour of RC beam exposed to 500^oC

Fig.15 Load – Deflection behaviour of RC beam exposed to 600 °C

Fig.16 Load – Deflection behaviour of RC beam exposed to 700 °C

The rate of deflection gradually increases as the temperature to which the beams are exposed increases. Due to the increase in the temperature, the beam loses its strength proportionally. Therefore the load bearing capacity decreases which leads to the rise in deflection. At all temperatures, the stiffness of the beams repaired with steel fibres has been observed to be more than the beams repaired with polypropylene fibres. The area covered by the load-deflection curve is an index for toughness of the material. It is observed that in majority of the cases, the toughness of beams repaired with steel fibres has been

observed to be more than that of beams repaired with polypropylene fibres.

Fig.10 to Fig.16 show the load-deflection behavior of beams exposed to temperatures 100, 200, 300, 400, 500, 600 and 700°C respectively. Fig.17, shows the variation of percentage flexural strength with temperature. It was observed that at all temperatures, the flexural strength of the beams repaired with steel fibres has been observed to be more than that of beam repaired with polypropylene fibres. Up to 400°C beams repaired with steel fibres has a marginal increase in flexural strength compared to that of heat exposed beams but for 500 to 700°C range it performs better than heat exposed beams.
