Ballistic Failure Mode of Apus Bamboo Strips Reinforced Epoxy Composite Materials

Sofyan Djamil¹, NPG Suardana², Agustinus Purna Irawan³ and IKG Sugita⁴

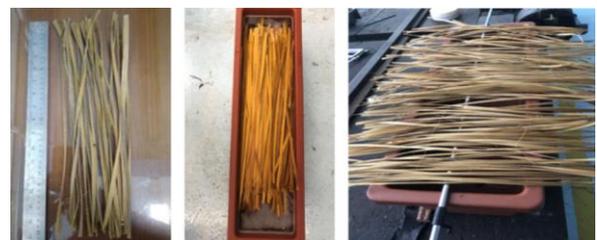
The bamboo strips used in this study were Apus Bamboo (Gigantochloa Apus), taken from Pebasiran village, Parung Panjang, West Java, Indonesia. The bamboo is cut manually using a strip knife with a thickness of 0.5 - 0.7 mm and a width of 5 - 7 mm. The bamboo strips were soaked in 5% NaOH for 72 hours and dried for 48 hours at room temperature (Fig. 1). The bamboo fibres are then heated in an oven at a temperature of 40^0C for 2 hours to remove the moisture content in the fibre and are made woven (Fig. 2)

Fig. 1. Bamboo Strips Preparation

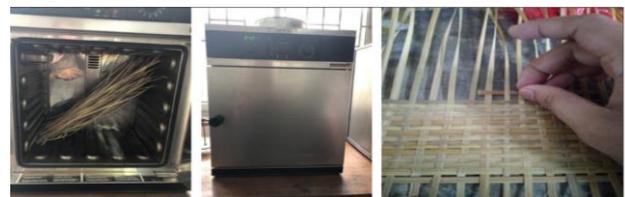
Fig. 2. Bamboo Strips Drying Process at a Temperature of 40^0C

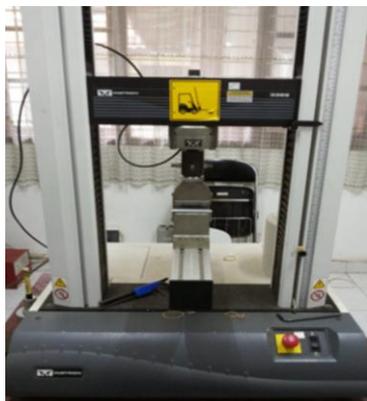
In reference to the ASTM D 3039 standard, tensile testing was conducted by using the Universal Testing Machine in a room temperature of 22°C and relative humidity of 63%. The crosshead speed for tensile testing was 2 mm/min. The dimensions of the specimens for tensile testing were 250 x 25 x 4 mm (length x width x thickness). Six samples were tested for tensile testing. The average values were reported including the standard deviations. The Universal Testing Machine and the process of tensile testing are shown in Fig. 4. Each sample was loaded to failure. Based on tensile testing will be obtained for tensile strength and Young's Modulus of the BSRECM [10].

Fig. 4. Tensile Specimen Test of the BSRECM

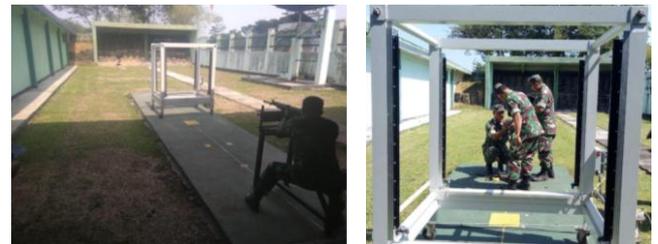
Ballistic testing was carried out at the ballistic testing laboratory of the Indonesian Army Research and Development Agency (Dislitbangad), Bandung, Indonesia, as in Figure 6. This test was conducted by the use of 5.56 mm bullets (MU5-TJ) with an Indonesian-made SS1 gun by the serial number of JaT 97045854, bullet speed $900 \pm 30 \text{ m/s}$, firing range of 25 m. Observations on ballistic test results focused on the failure mode that occurred in the BSRECM.

Fig. 6. Ballistic Testing Process of the BSRECM

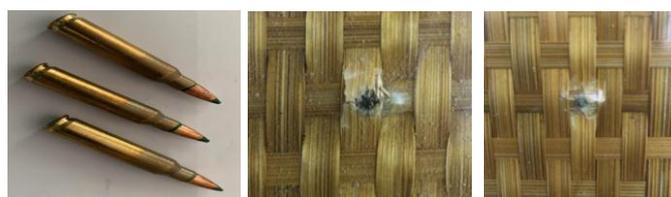
Fig. 8. Ballistic Test Results of the BSRECM $0^0/0^0/0^0$ Laminate

Fig. 8 shows the ballistic test results of the BSRECM $0^0/0^0/0^0$ laminate configuration and bullet velocity of 894.2 m/s. The front and back views of the specimens show the partial penetration failure mode in the form of small deformations around the area of damage. In Fig. 9, the SEM observations on the front surface of the ballistic test specimens with the BSRECM $0^0/0^0/0^0$ laminate configuration show the fracture area of the front surface as a result of the initial impact load, which occurs in the front surface of the BSRECM. Most of the load strikes the fibres on the bamboo strips, causing damage which causes failure. However, due to the layer configuration, which allows low damage rates, the bamboo strips are not completely but only locally damaged.

Ballistic testing aims to observe the response of the BSRECM in receiving a bullet load at a certain speed. The response that occurs can be observed from the form of failure mode due to the load from the bullet fired at a certain distance and speed. Ballistic testing was conducted using SS1 rifles with 5.56 mm calibre bullets (MU5-TJ), a firing range of 25 m, and a BA 04 S type bullet velocity gauge. The test sample was a $0^0/0^0/0^0$ laminate configuration, 3 layers and volume fraction of 30%. Ballistic test results are shown in Fig. 8.
